INSPECTION REPORT

INSPECTOR'S NAME Nick Ostrowski - (ASHI Member Number: 261678)
NAME OF BUYER(S)
ADDRESS OF PROPERTY
CITY STATE PA ZIP CODE 12345
REALTOR COMPANY AGENT PHONE#

WEATHER CONDITIONS sunny 64°
TIME 2:00pm DATE 10/13/2023

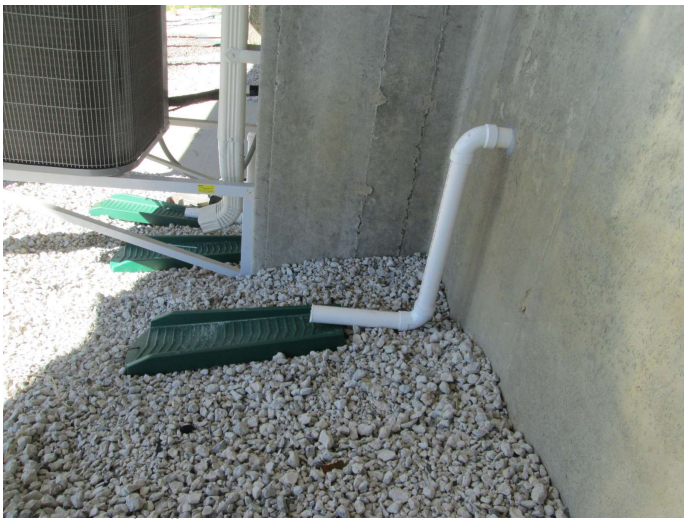
**sump pump discharge pipe at rear exterior**

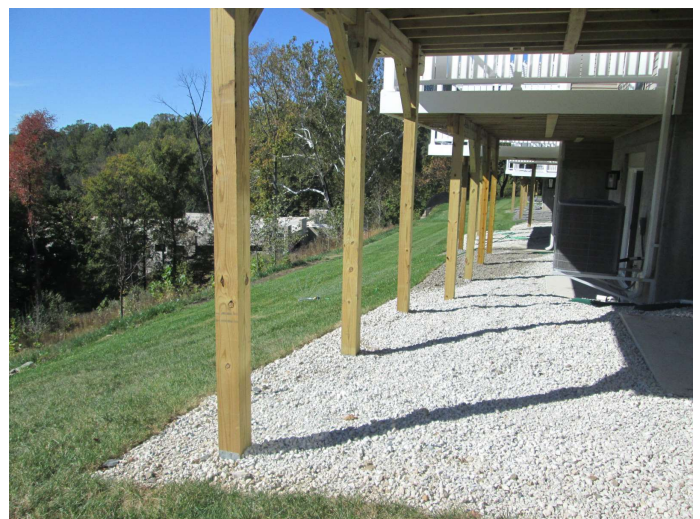
**grades sloped away from house**

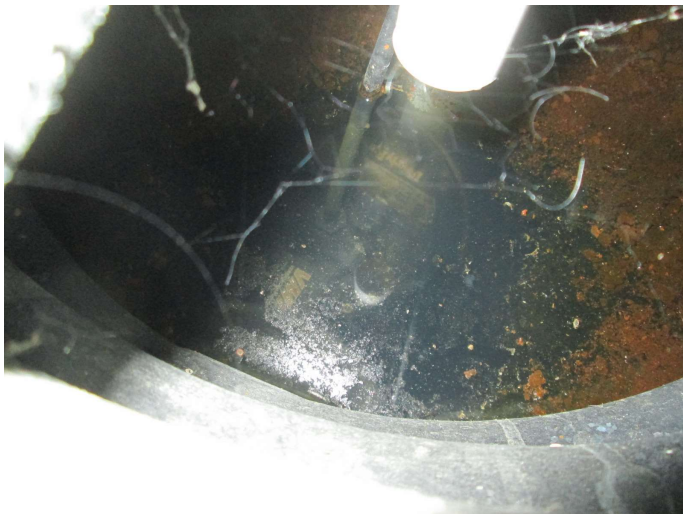
- 2 - sump pit with pump noted at the right-hand rear corner of the basement - standing water noted in the pit but pump in pit is completely submerged and pump not activating (pump needs to be made operable)

sump pump submerged in pit

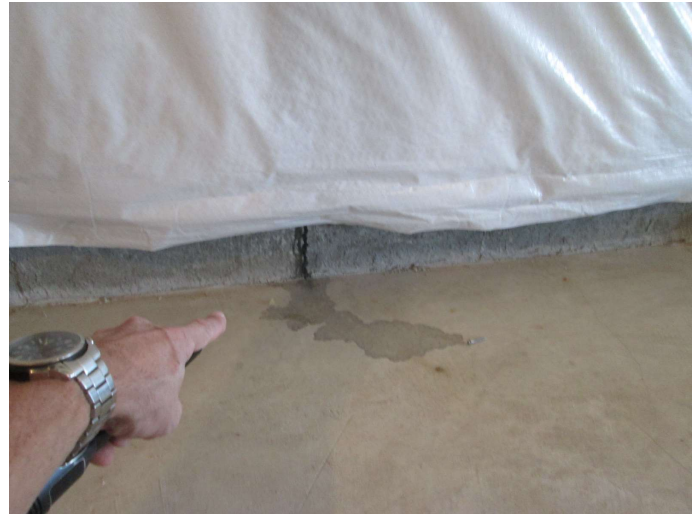
- 1 - interior foundation walls in basement partially covered with insulation and not totally observable - evidence of water penetration noted on floor surface at the front of the basement (staining on floor beneath the main water service line and main sanitary drain line) // water penetration staining noted on the left-hand side foundation wall and floor surface (shrinkage crack on wall and water staining around the crack - recommend having crack filled and sealed to prevent future water penetration)

water penetration staining

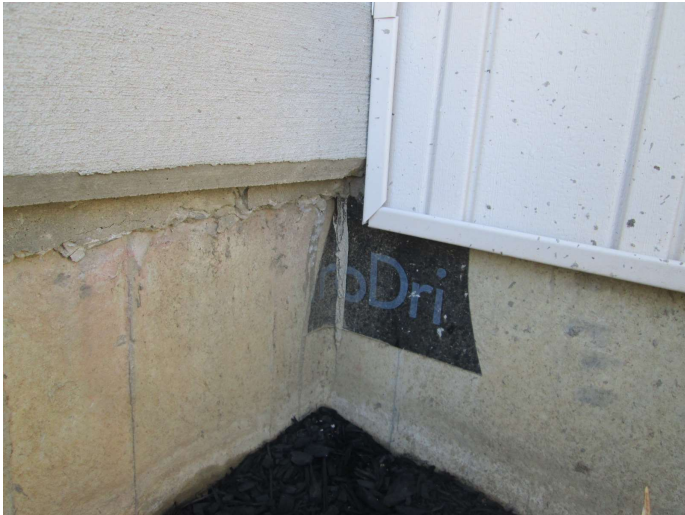
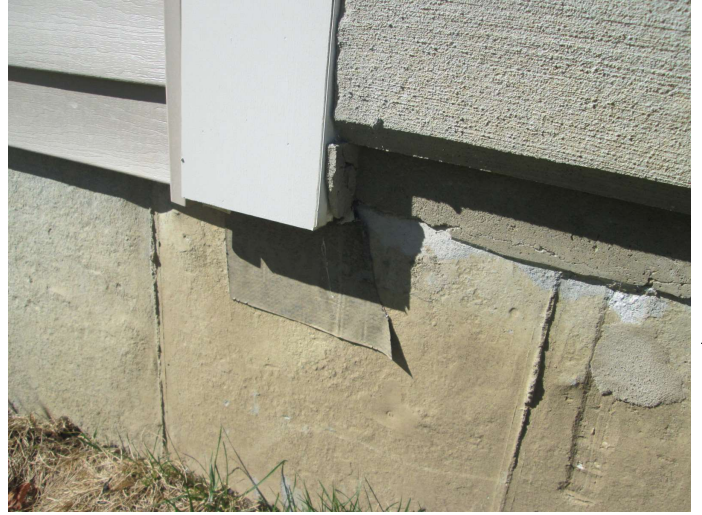
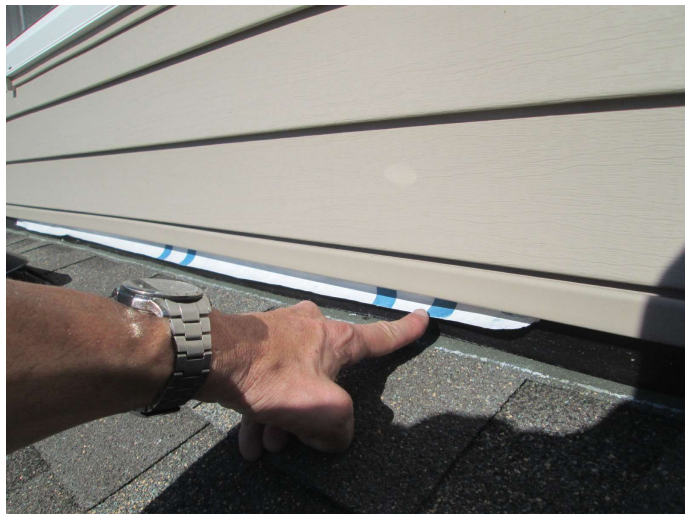
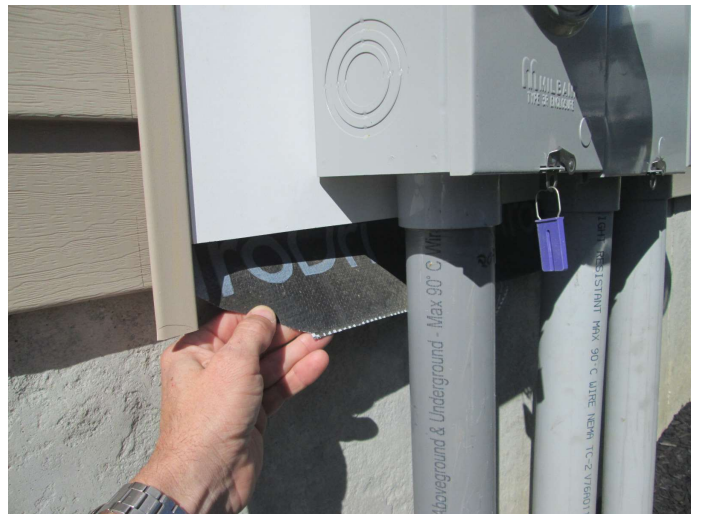
1 - recommend having exposed areas of house wrap removed (to the right of the front entry steps, beneath the exterior main service disconnect box, to the left of the front entry porch, at flashing line above the 1st floor rear roof)

exposed house wrap

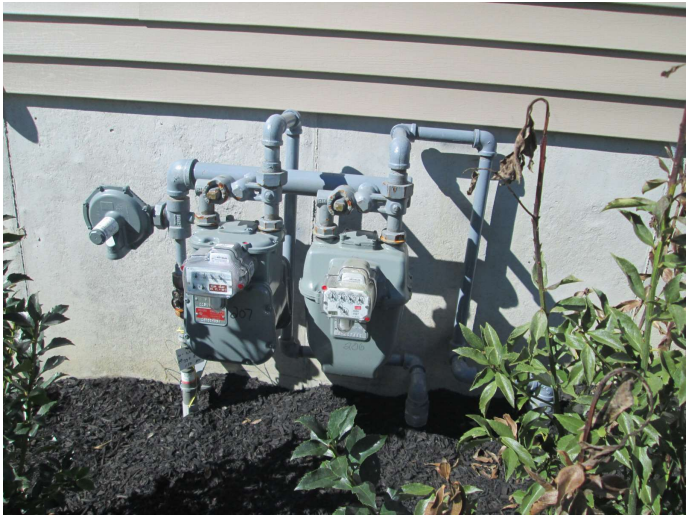
view of gas meters

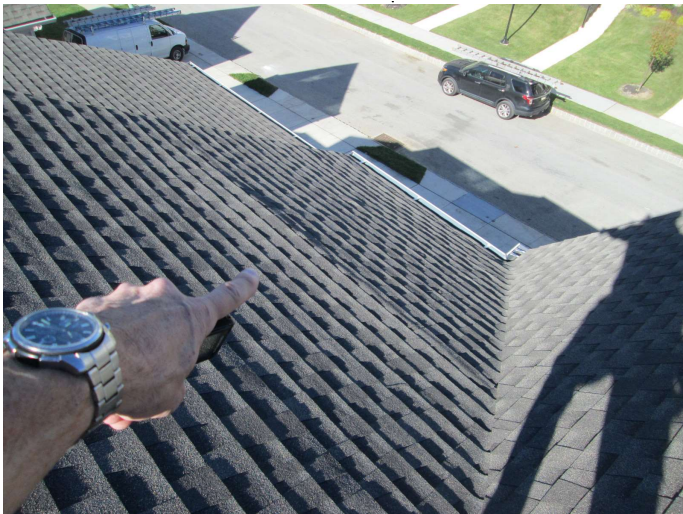
1 - lower front roof above the garage doors (A) is a standing seam metal roof (no defects noted) // lower front roof above the garage (C) is covered with one layer of dimensional asphalt shingles - green plastic tab noted stapled to the roof surface (staple in shingle tab may result in leaks - repairs needed) // roof above the front entry door and detail roof above the 2nd floor front bedroom windows (A) are standing seam metal roofs (no defects noted) // 1st floor rear lower roof (A) is covered with one layer of dimensional asphalt shingles (no defects noted) // main gabled roof surfaces (C) are covered with one layer of dimensional asphalt shingles - multiple loose nails noted on the roof surfaces (all nails and loose construction debris should be removed) - buckled area of shingles noted at the lower right-hand front corner of the main roof (shingles deflect when stepped on - roof decking beneath the shingles appears to be buckled and not laying flat and may make shingles in this area susceptible to wind tear-off (repairs needed)

buckled shingles on front of main roof

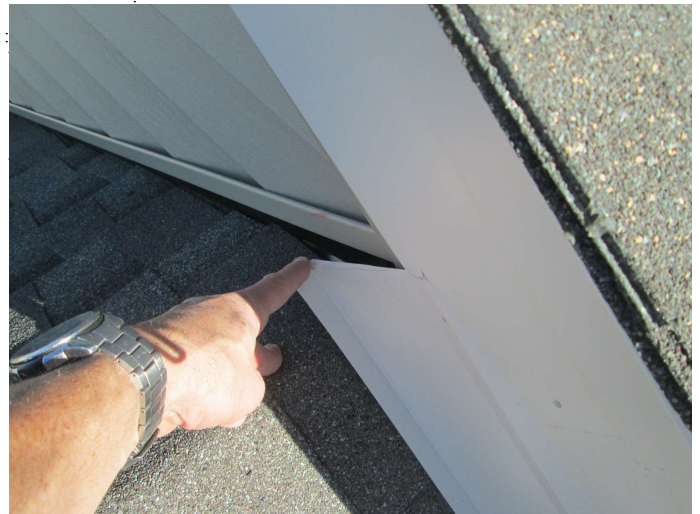
2 - section of fascia capping along the rear right-hand side fascia of the main roof has an open and unsealed edge that may allow water penetration as well as bird, bat, and insect entry (repairs needed)

gap at fascia capping

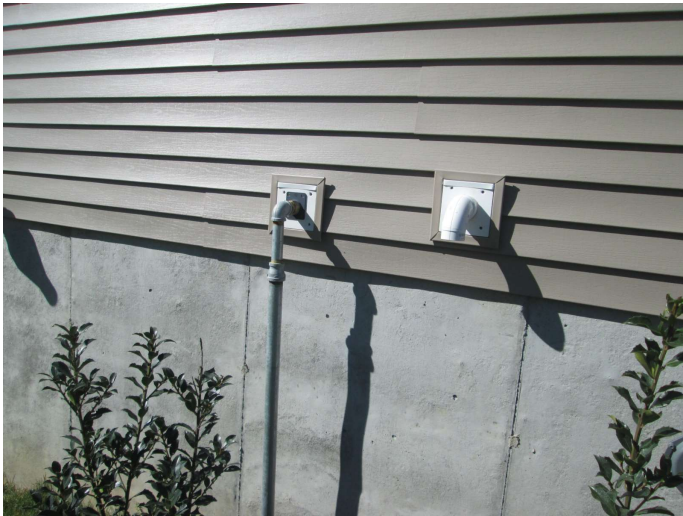
**water heater vent pipe**

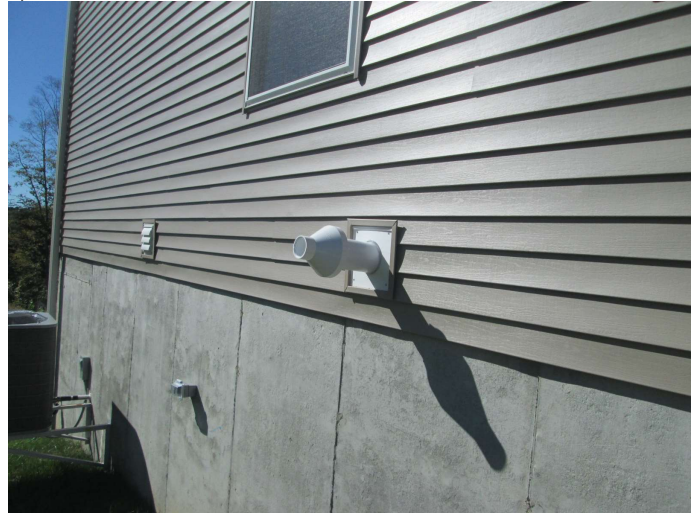
**furnace vent pipe**

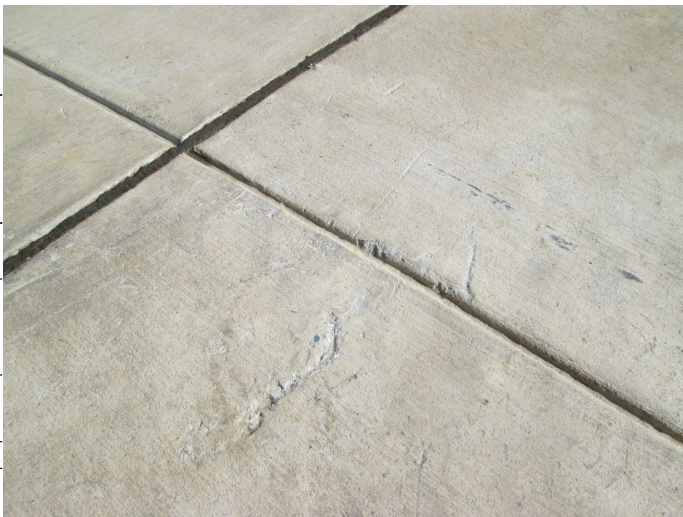
**gouges on surface of sidewalk**

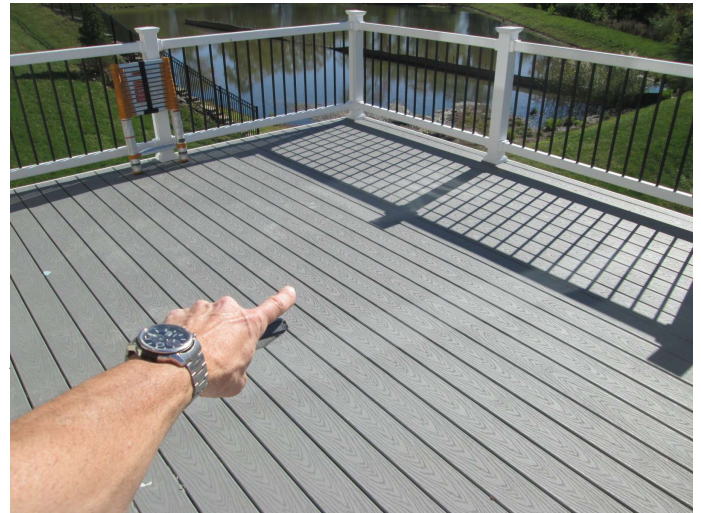
1 - rear deck structure noted as swaying and moving with side-to-side with foot pressure on the deck surface (repairs needed to stabilize deck and prevent movement)

**deck sways with side-to-side foot pressure on deck surface**

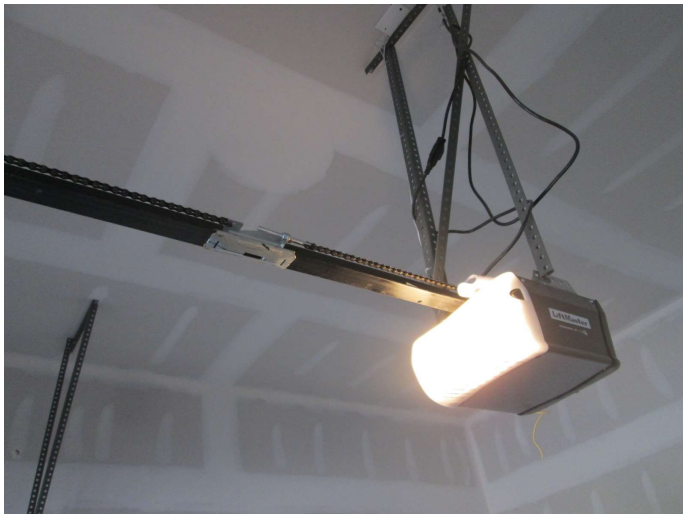
garage door disconnected from opener

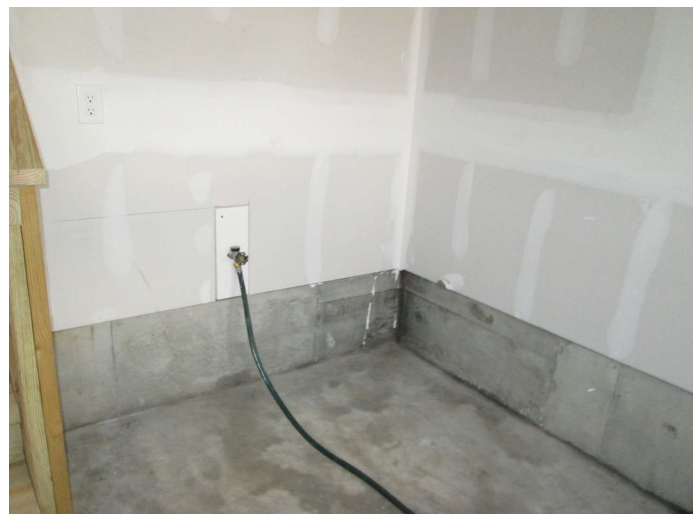
dampness inside garage

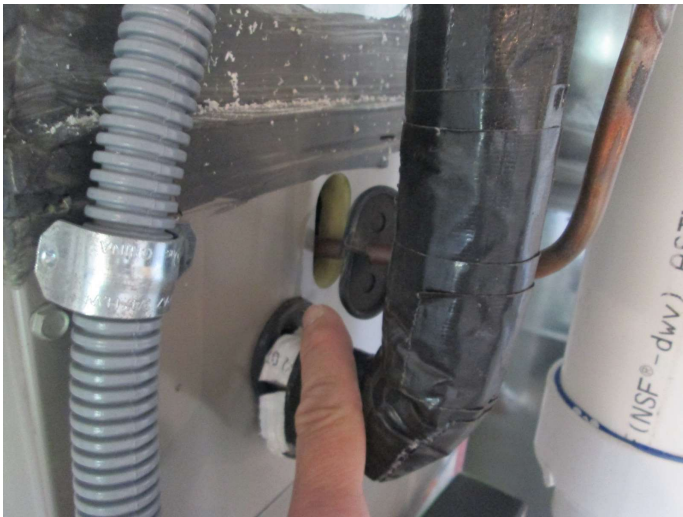
1 - heat source is a less than 1 year old gas-fired high efficient forced air furnace (zone #1 thermostat in the 1st floor family room and zone #2 thermostat in the 2nd floor front bedroom) - system tested and noted as operable - debris noted inside the furnace cabinet behind the front access panel (have all debris removed) - grommet on the supply plenum of the furnace around the AC lines is not installed properly and air leaks noted (repair)

air leaks - grommet not secured

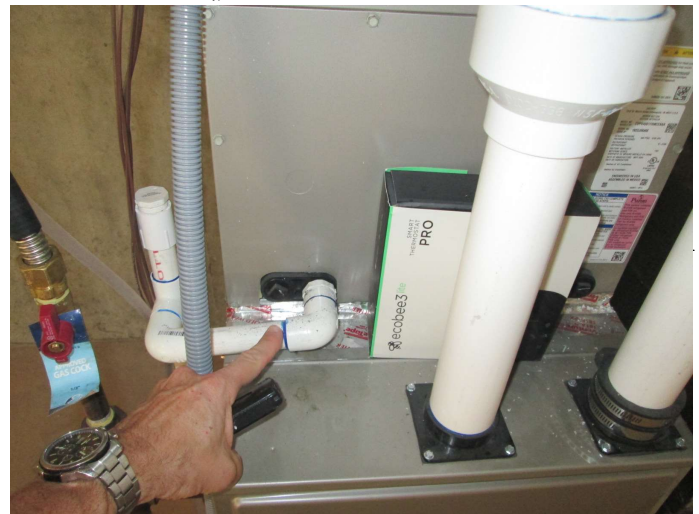
air leaks

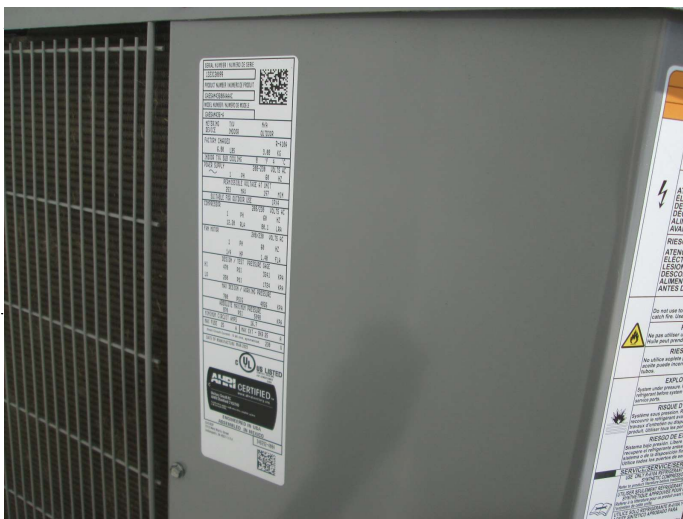
**<1 year old 3 ton AC condenser**

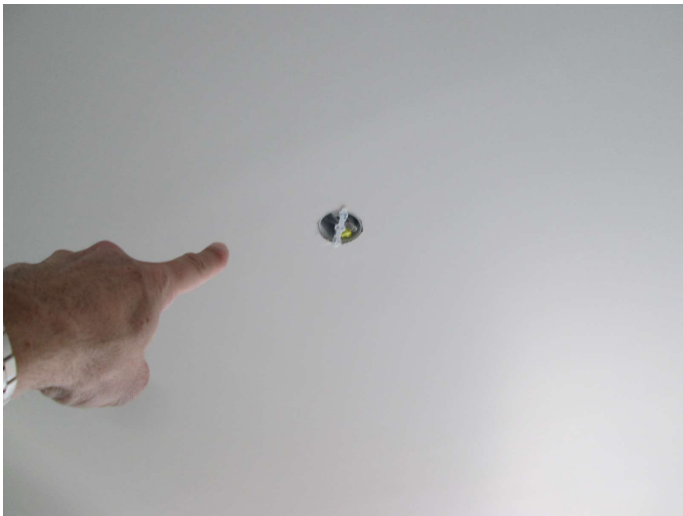
2 - open junction box with exposed wire splice noted at ceiling level in the kitchen above the island sink (have coverplate installed)

coverplate missing - wiring splices exposed

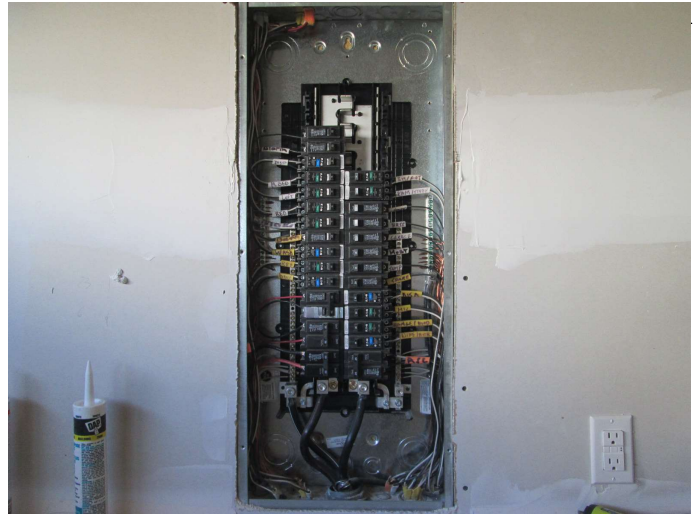
view of service panel

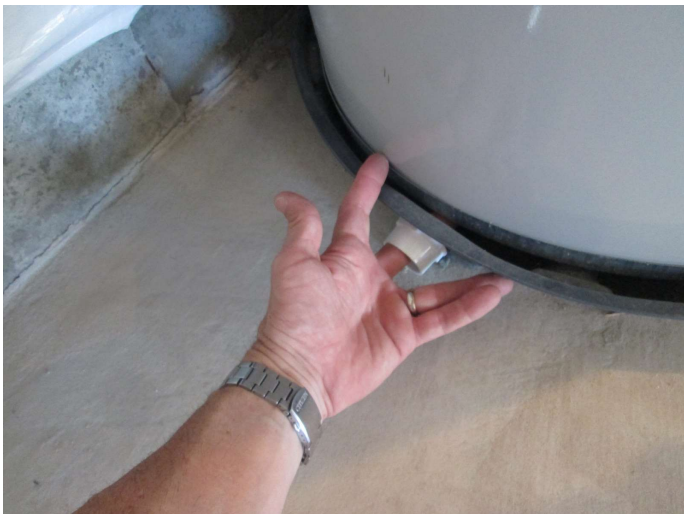
no drain line on water heater overflow pan

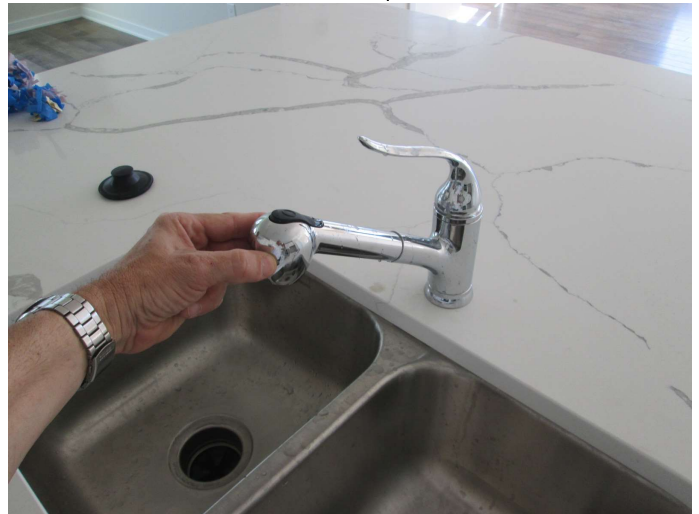
faucet not properly secured

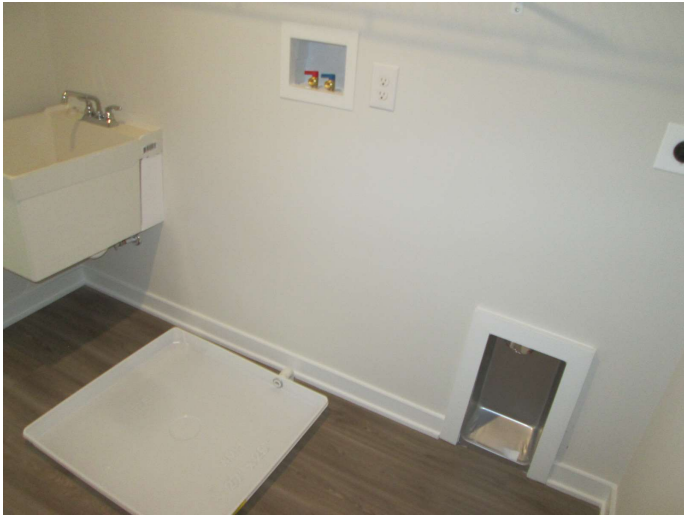
**view of laundry room**

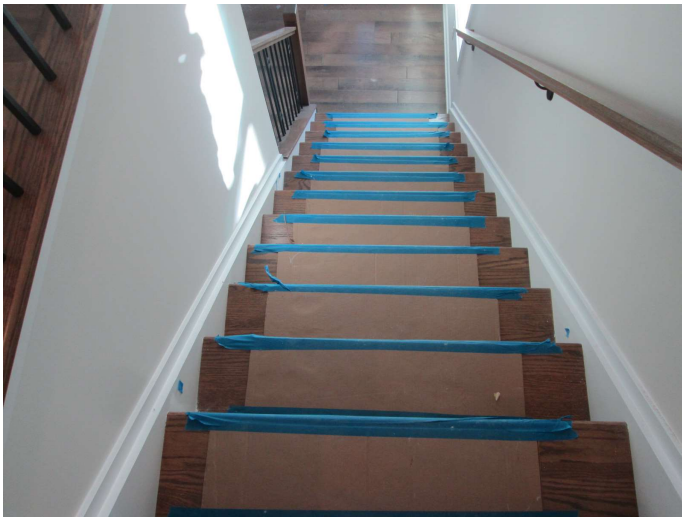
cardboard and tape on stair treads

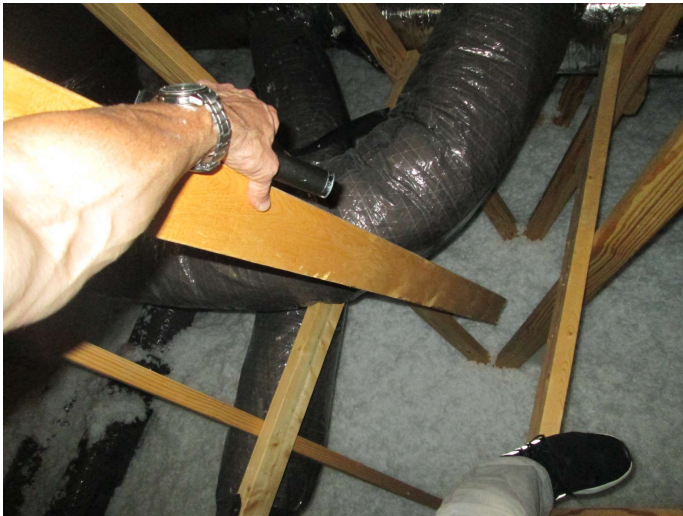
- 1 - attic area above 2nd floor rooms was accessed via panel on ceiling of closet in the 2nd floor front bedroom - attic interior not totally observable due to insulation levels and HVAC ducts
- 2 - one diagonal bracing member to the right-hand side of the attic noted as not secured at the base (repair)

**unsecured bracing member in attic**

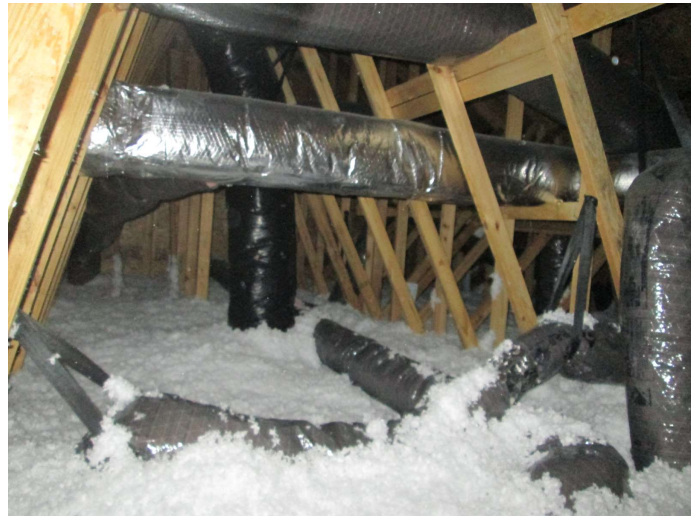
**view of attic**

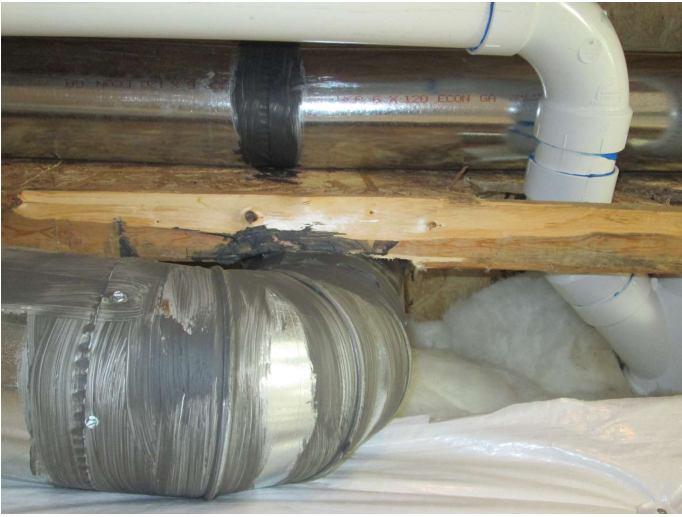
- 4 - improper notching of bottom chord of I-joist at ceiling level left-hand side of the basement behind the staircase for routing of an HVAC duct (repairs needed)

**bottom chord of I-joist improperly notched**

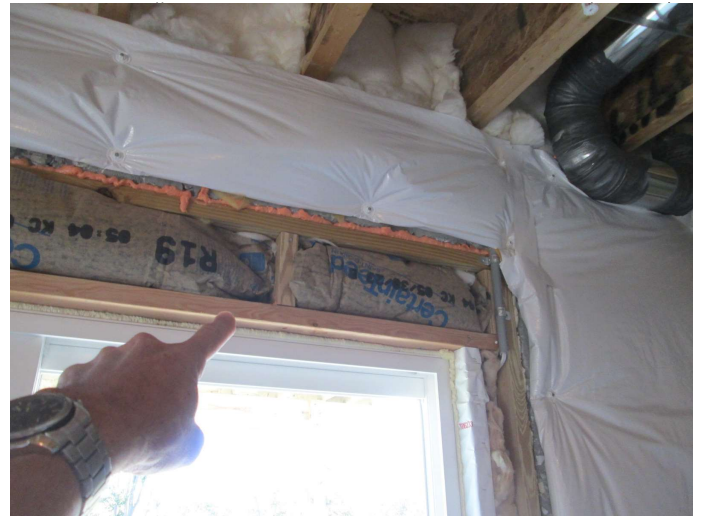
- 3 - paper facing improperly left exposed on insulation around the sliding glass door at the rear of the basement (exposed facing poses a fire hazard and should be removed)

**exposed paper facing poses fire hazard**

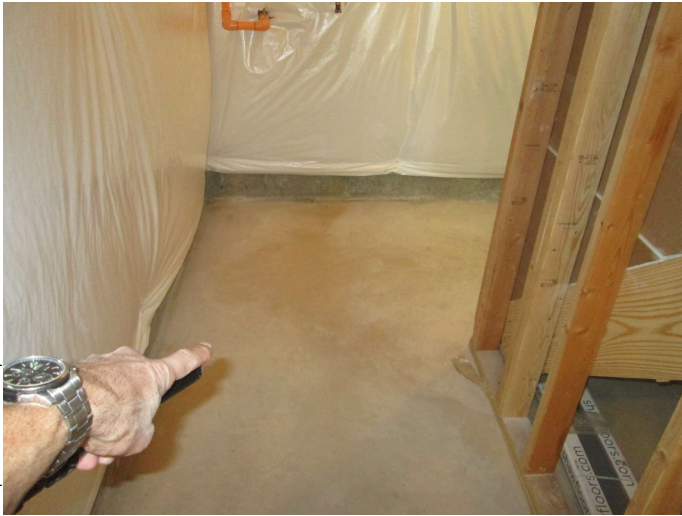
**water penetration stain on floor**

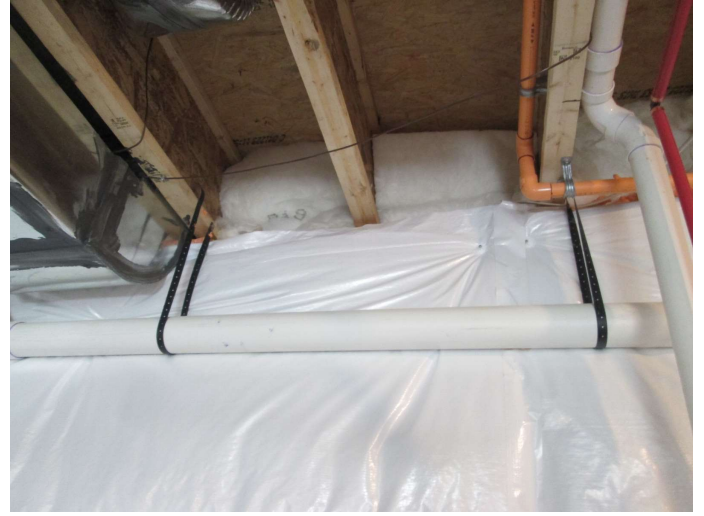
- 1 - improper use of flexible vinyl straps to support the main sanitary drain line in the basement (flexible straps do not resist movement of the drain line - repair)
- 2 - water supply line noted at the front for the basement for the fire sprinkler system
- 3 - roughed in plumbing drain lines and ejector pit noted on the floor in the basement for a future basement level bathroom

**improper use of flexible vinyl straps to support drain line**

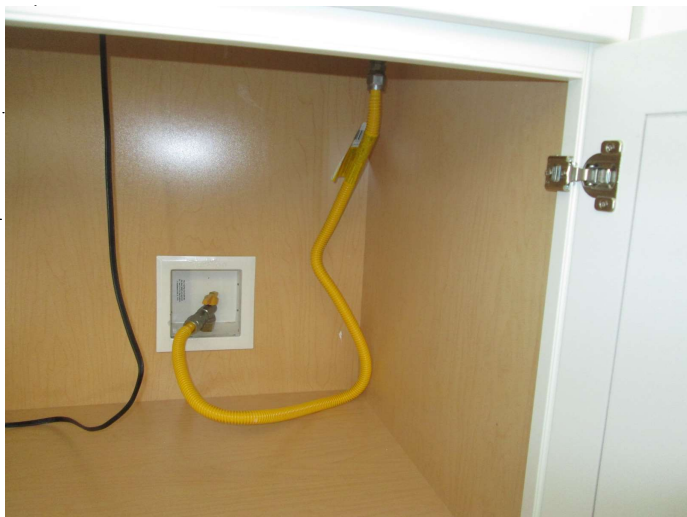
**recommend having gas line secured up and off cabinet floor**

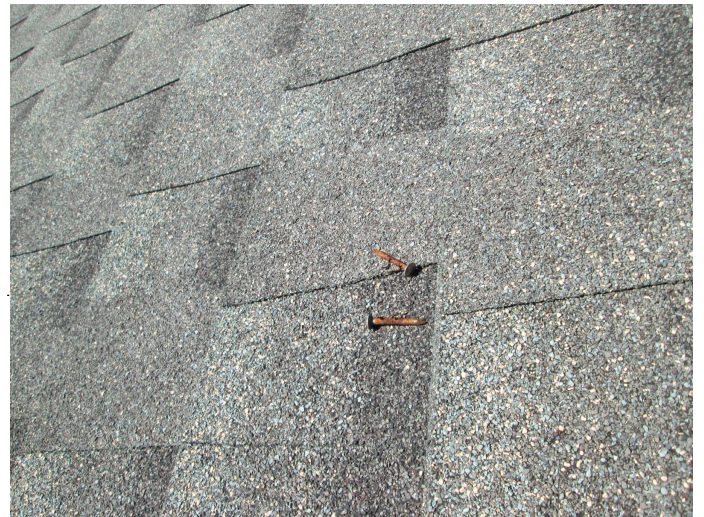
**loose nails on roof**

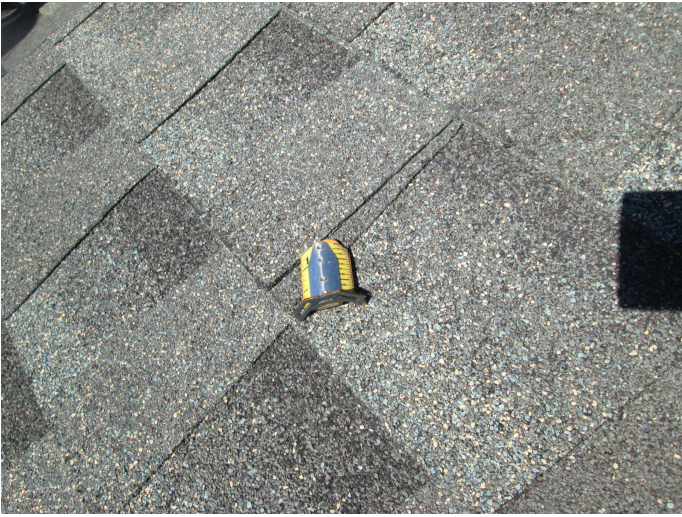
**construction debris on roof**

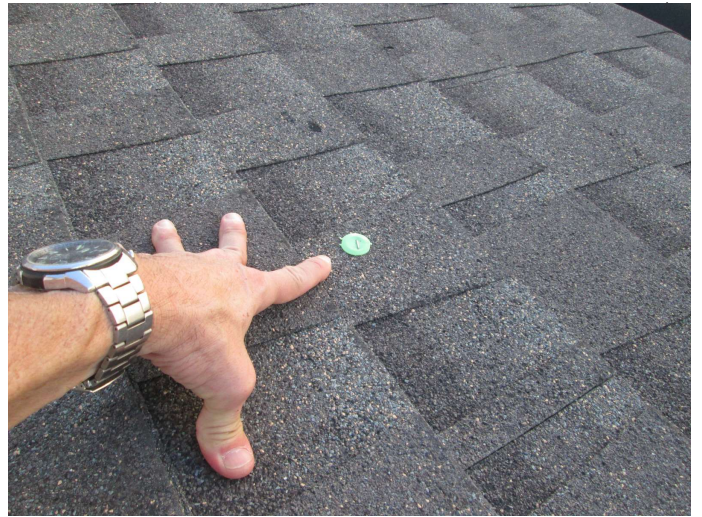
**plastic tab and staple in shingle**

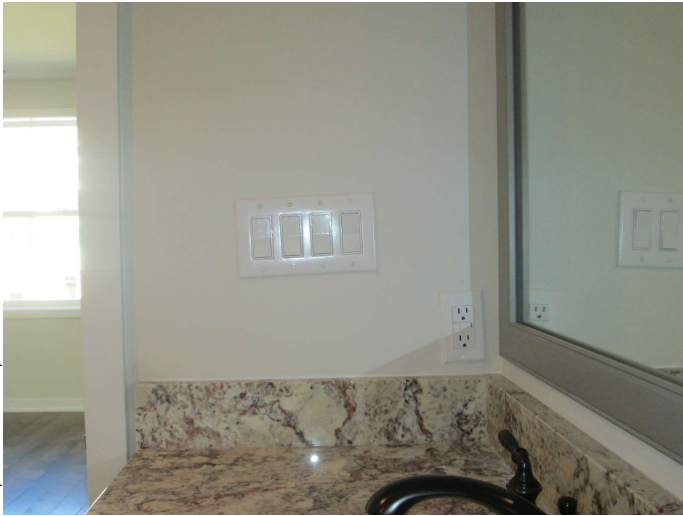
3 - light switches and outlet installed out of level in the wall above the sinktop in the 2nd floor master bathroom (repair)

**switches and outlet installed out of level**

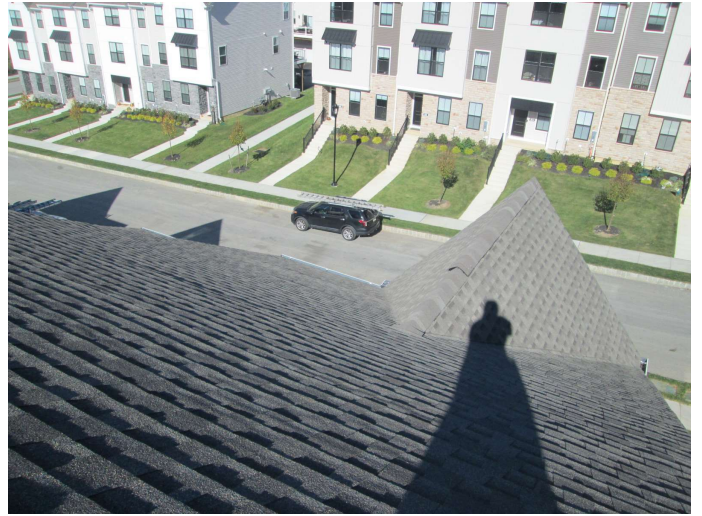
**view of roof**

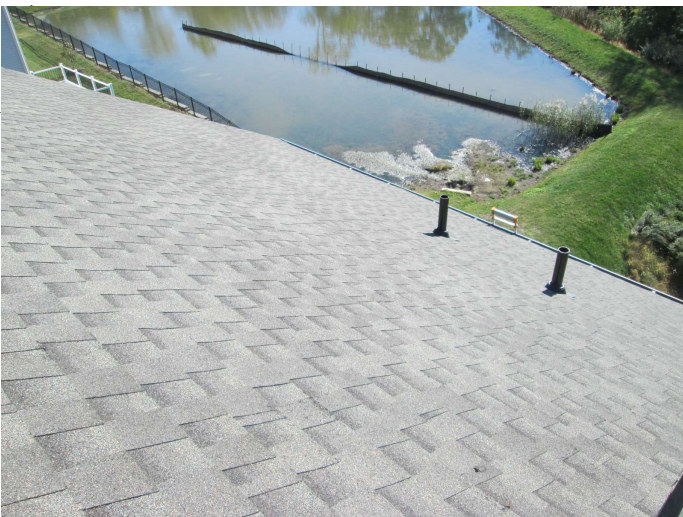
**view of roof**

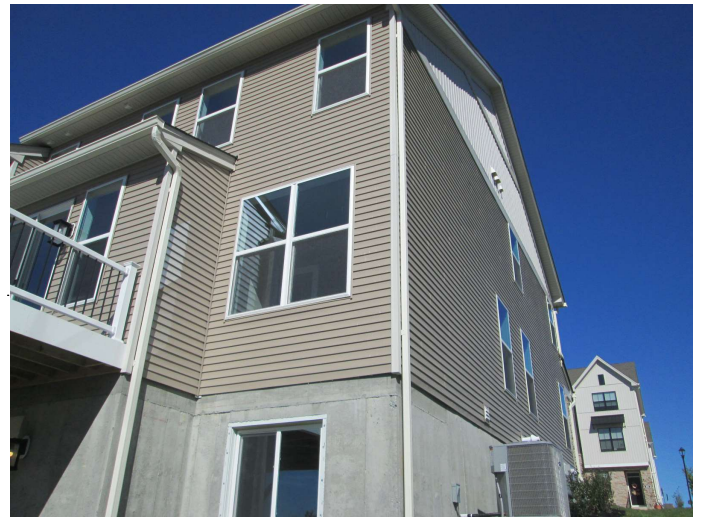
**view of rear exterior**
