INSPECTION REPORT

WEATHER CONDITIONS sunny 62°
TIME 12:45pm DATE 3/12/2024

- SINGLE HOME
SEMI-DETACHED
ROWHOME
SINGLE STORY
MULTI-STORY
OTHER
OCCUPIED VACANT new construction

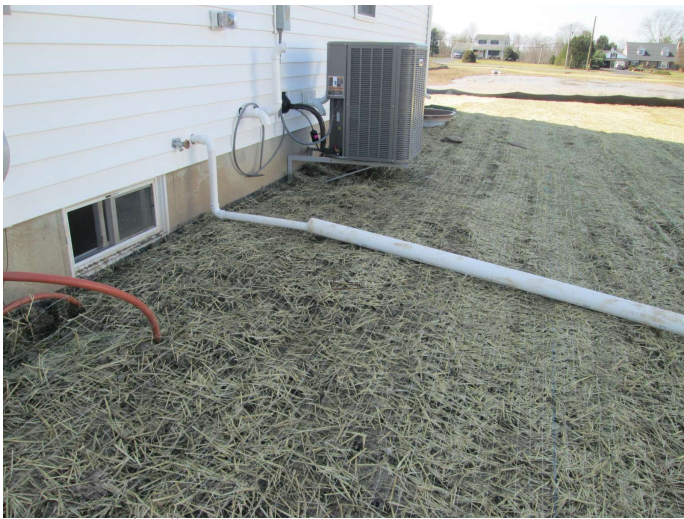
2 - sump pump discharge line along the right-hand side exterior is extended with a PVC pipe on grade surface to exhaust sump pit water further away from the foundation

temporary extension of sump pump discharge pipe

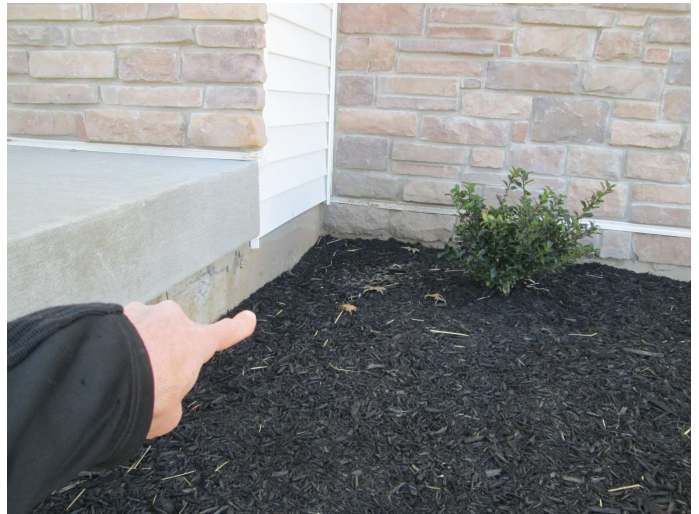
1 - grades to the right of the front entry door, right-hand side grades around the AC condenser, and rear grades at the inside corner of the foundation wall are sloped towards the foundation (may result in water penetration in the basement - exterior grading needs to be corrected) // no grass noted in the right-hand side, left-hand side, and rear yard areas

grades sloped towards house

FLAT LOT SLOPED LOT Grading needs to be raised around the perimeter of the foundation with clay soil. Grading should be sloped a minimum of 1/2 inch per foot of run going away from the exterior walls for at least eight (8) feet.

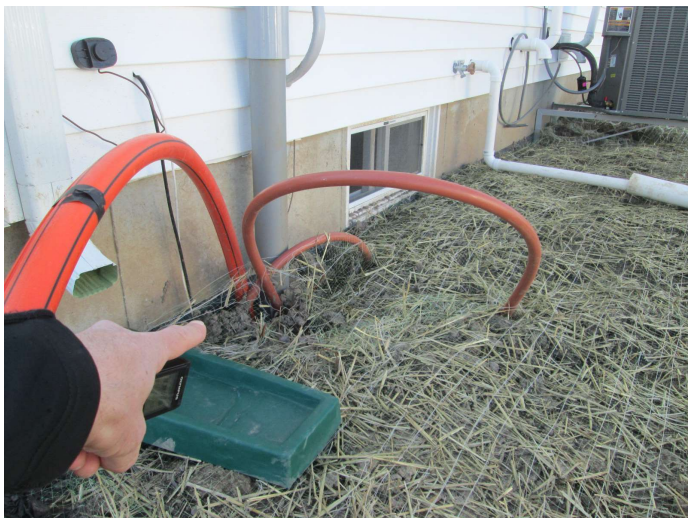
grades sloped towards house

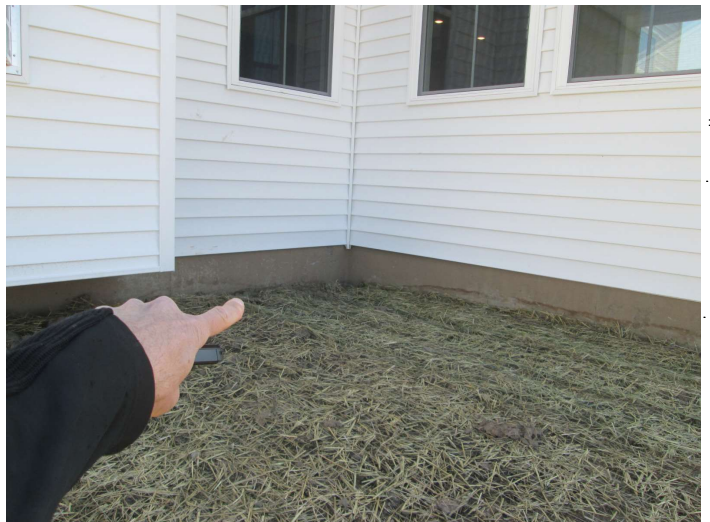
grades sloped towards house

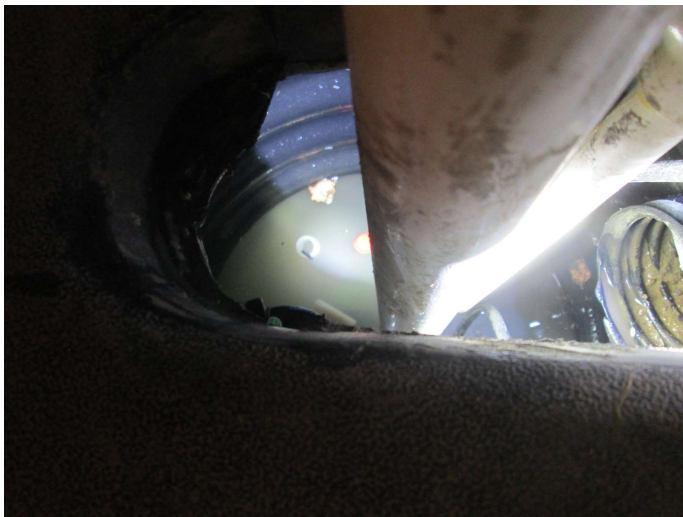
2 - sump pit with pump noted along the right-hand side of the basement - standing water noted in the pit (water was over top of the float switch and pump was not activating) - sump pit lid was moved and pump activated - construction debris noted in the sump pit and may result in blockage of the pump (all debris needs to be removed from the sump pit to ensure proper operation of the sump pump)

construction debris in sump pit

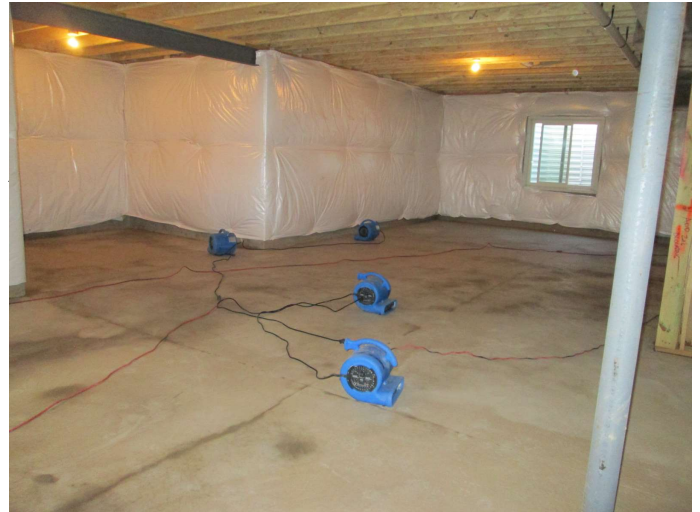
1 - builder rep stated basement had been powerwashed prior to the inspection (floor surfaces and exposed base of foundation walls noted as damp at time of inspection) - multiple areas of dampness and moisture noted on the basement floor - insulation beneath the basement steps noted as wet (may result in mold / fungal growth) // foundation walls in the basement are covered with insulation blankets and not totally observable

dampness on basement floor

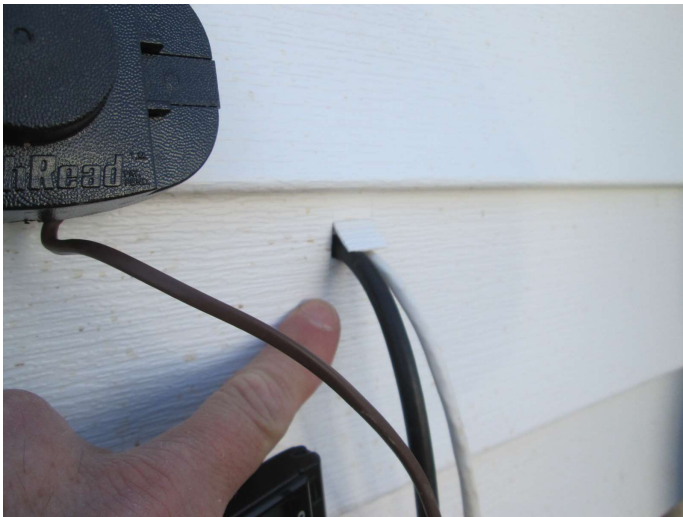
1 - multiple unsealed penetrations noted though vinyl siding along the right-hand side exterior wall (all penetrations need to be sealed to prevent water, insect, and rodent infiltration)

unsealed penetration

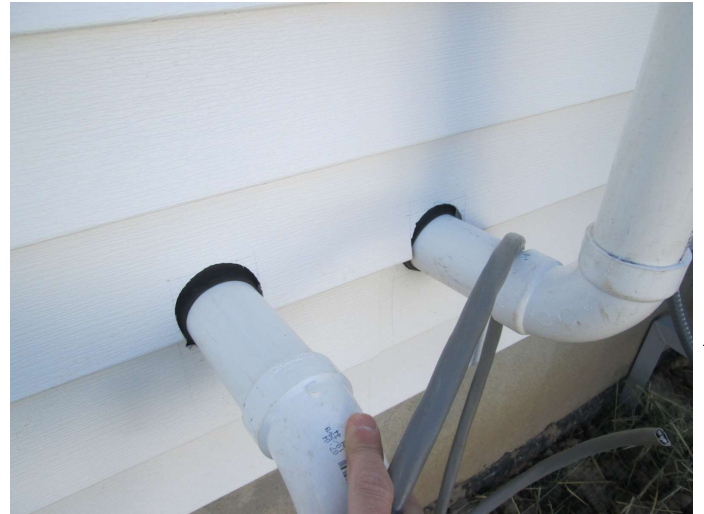
unsealed penetration

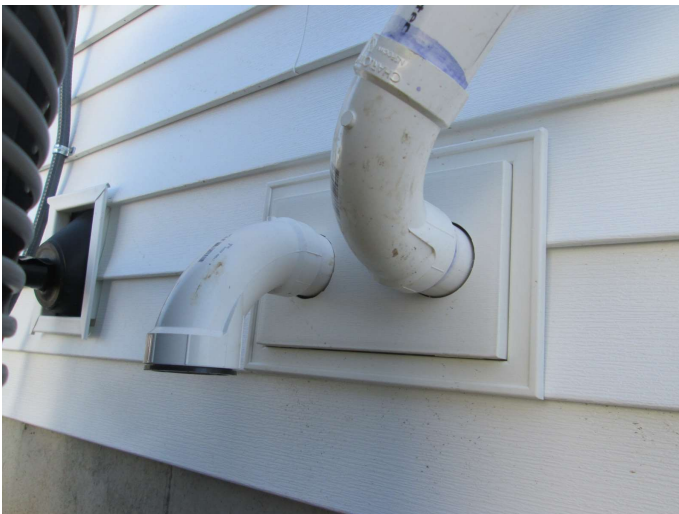
unsealed penetration

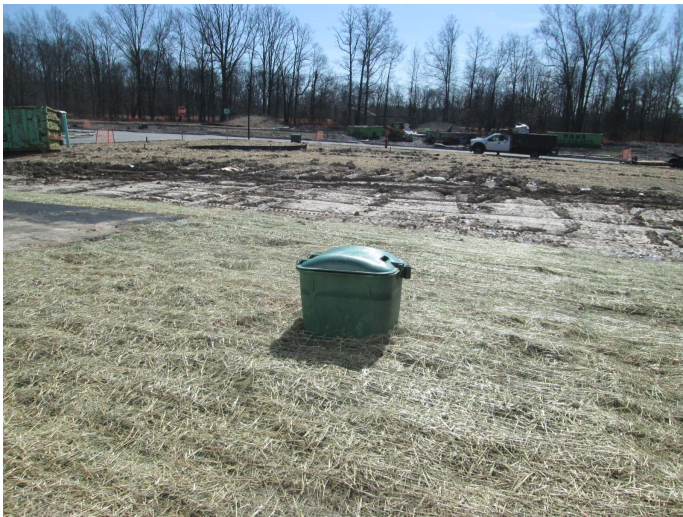
1 - buried propane gas tank noted in the left-hand side yard - main gas service line to the house noted along the left-hand side exterior

location of buried propane tank

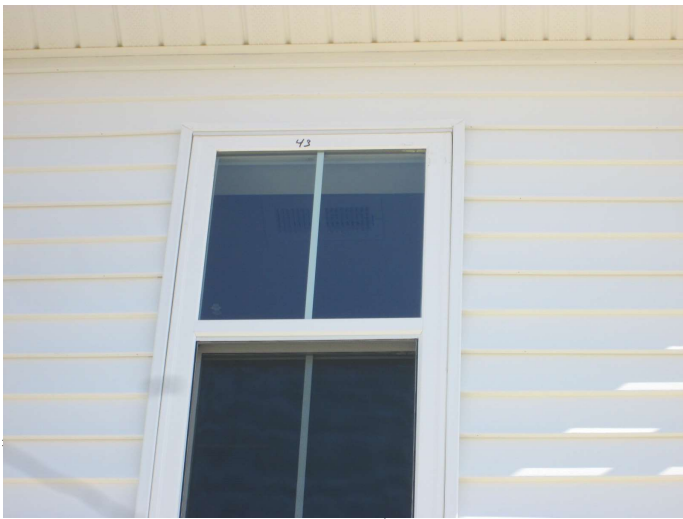
1 - number "43" noted written on window frame at the 2nd floor left-hand rear window

number "43" written on window frame

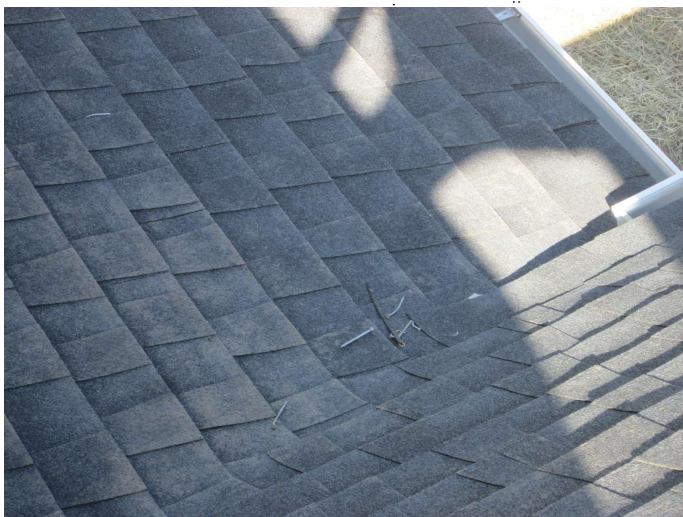
1 - 1st floor rear lower roof and roof above the rear fireplace bumpout (A) are covered with one layer of dimensional asphalt shingles (no defects noted) // main gabled roof and roof above the front entry door (C) are covered with one layer of dimensional asphalt shingles - loose nails and construction debris noted on roof surfaces (have all loose nails and construction debris removed)

loose nails on roof

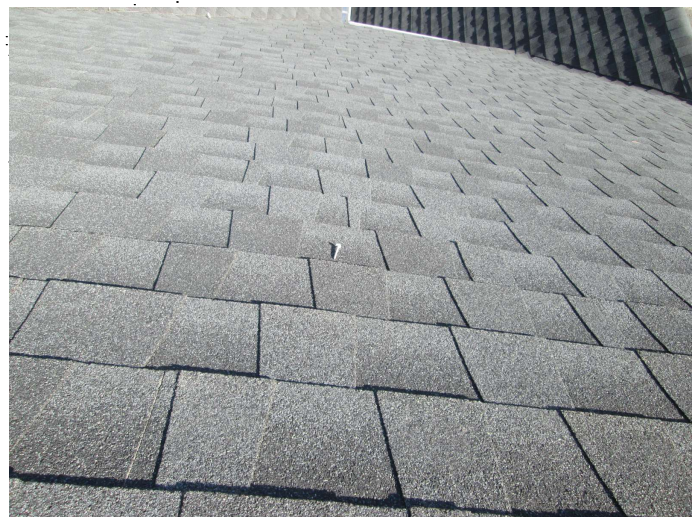
loose nails on roof

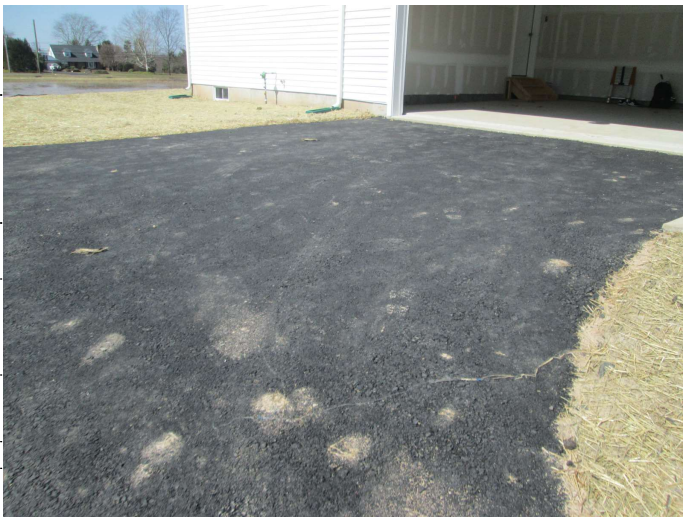
NI	PORCHES	_____
NI	DECKS	_____
C/I	WALKWAYS	_____
A	RAILINGS & HANDRAILS	_____
A	STEPS	_____
NI	BALCONIES	_____
C	DRIVEWAY	driveway installation noted as incomplete at time of inspection

driveway installation incomplete

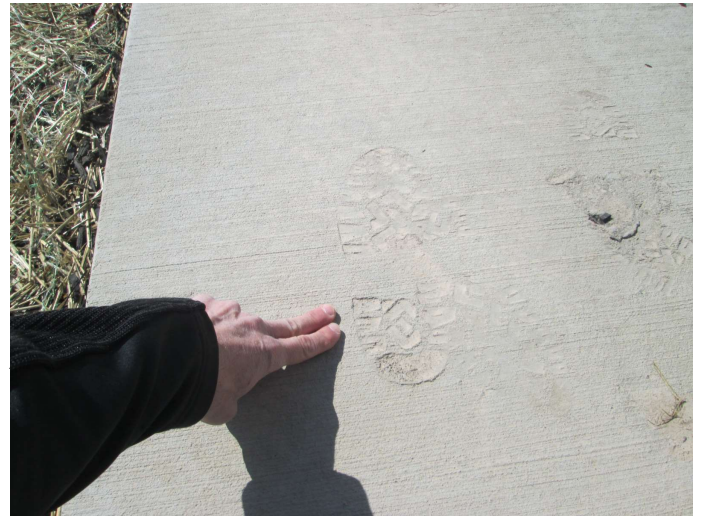
1 - boot prints noted on the surface of the concrete walkway surface adjacent to the driveway surface

boot marks on walkway surface

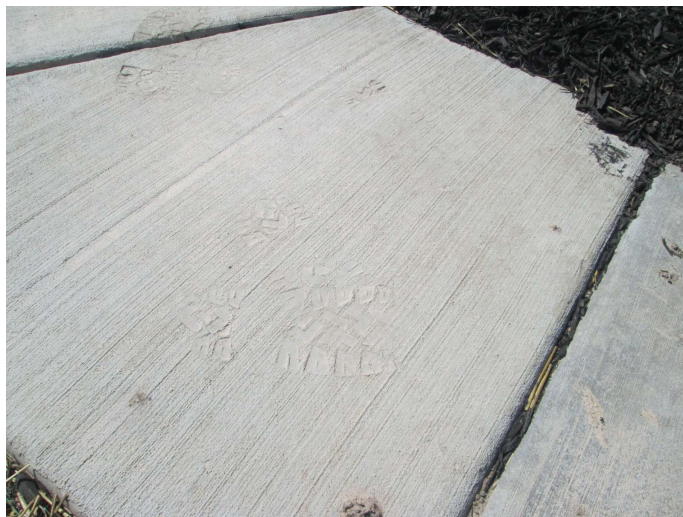
boot marks on walkway surface

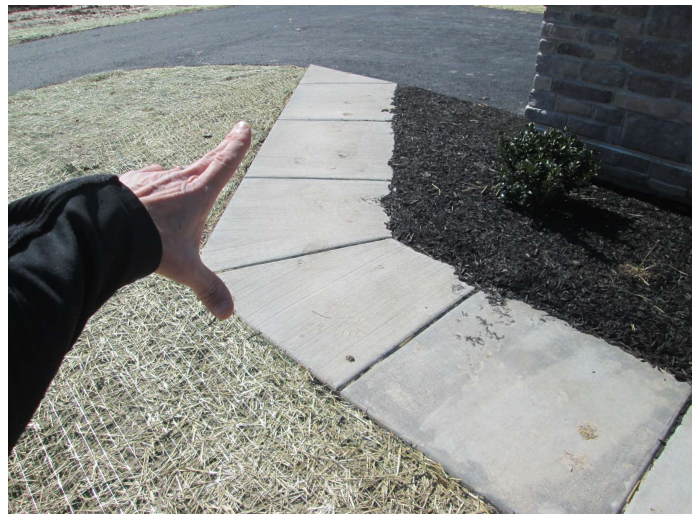
boot marks on walkway surface

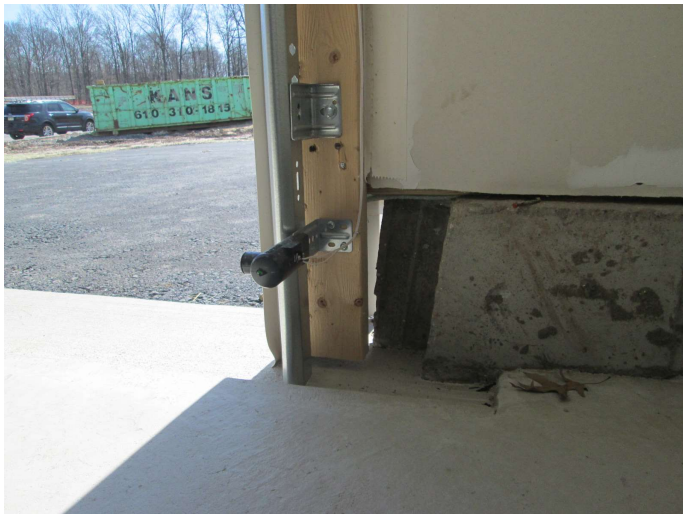
- 1 - unsealed gaps and openings noted around the trim boards of the entrance door into the garage (all gaps should be sealed and draft stopped for safety)
- 2 - garage door would not close when automatic opener was tested (door would travel approximately 2 feet when closing, stop, and go back up - door would not close with automatic opener - auto reverse sensors could not be tested for operability - repairs are needed to make automatic opener operable)
- 3 - unsealed gaps noted between bottom of exterior frames of the garage door and the foundation (daylight to exterior noted inside the garage - gaps may allow rodent and insect infiltration - repairs needed)

unsealed gap to exterior

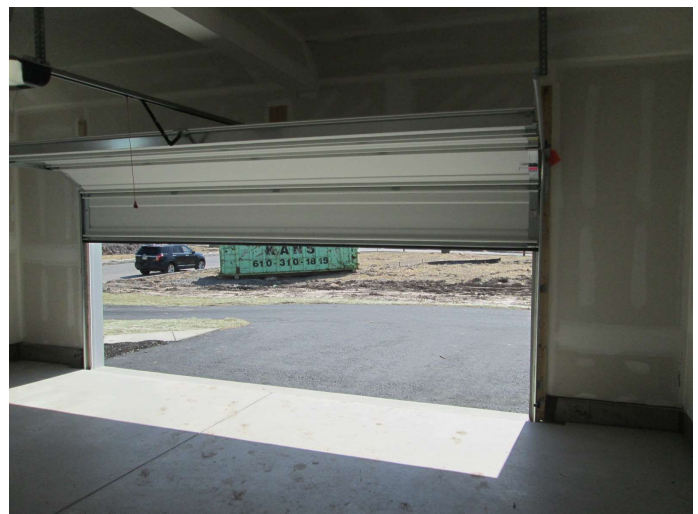
garage door automatic opener will not close door

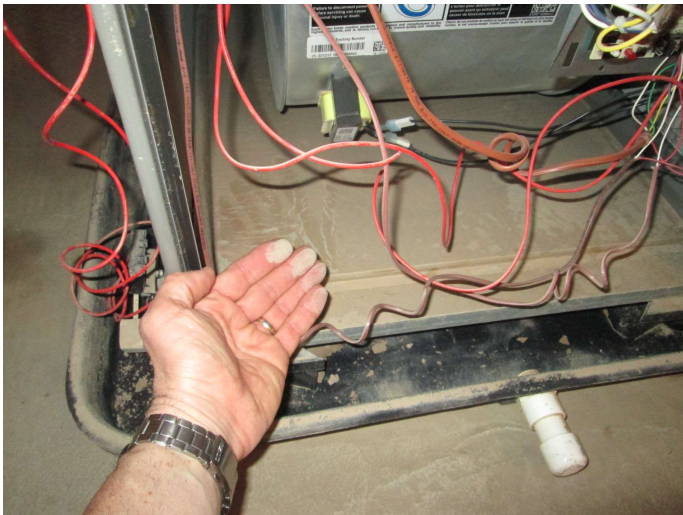
- 1 - heat source is a 1 year old gas-fired high efficient forced air furnace located in the basement (system tested at zone #1 and zone #2 thermostats and noted as operable) // furnace is set in an overflow pan in the basement with a water sensing shut-off float switch
- 2 - construction dust and debris noted inside floor level ducts in 1st floor rooms and inside the fan blower compartment of the furnace in the basement (have all duct interiors and furnace fan blower compartment cleared of all debris)
- 3 - flexible magnetized cover installed over the filter bay opening next to the furnace in the basement does not adhere properly (recommend having filter bay cover replaced)
- 4 - zone #1 thermostat located in 1st floor right-hand hallway - zone #2 thermostat located in the 2nd floor master bedroom

construction dust inside fan blower compartment

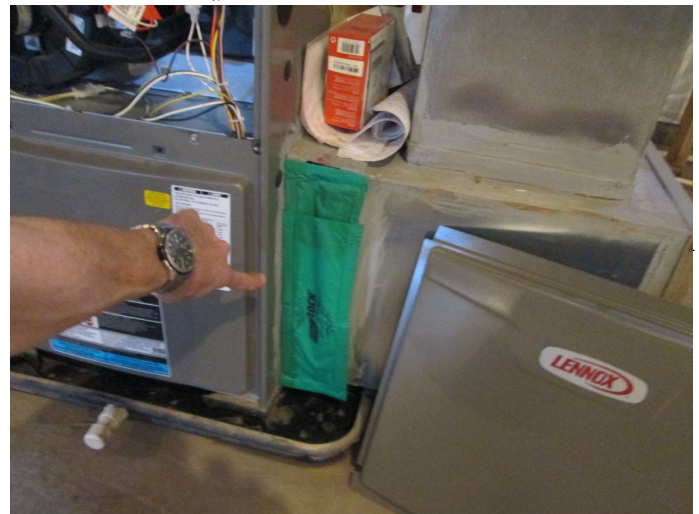
air filter cover not secure

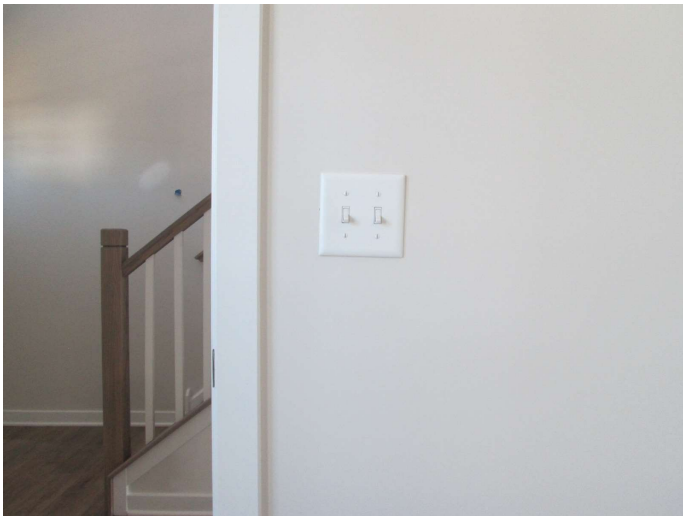
1 - junction boxes installed out of level on walls in the following areas (on wall to the left of the sink in the kitchen, on wall to right of the oven in the kitchen, on wall in 1st floor front office room,

junction box out of level

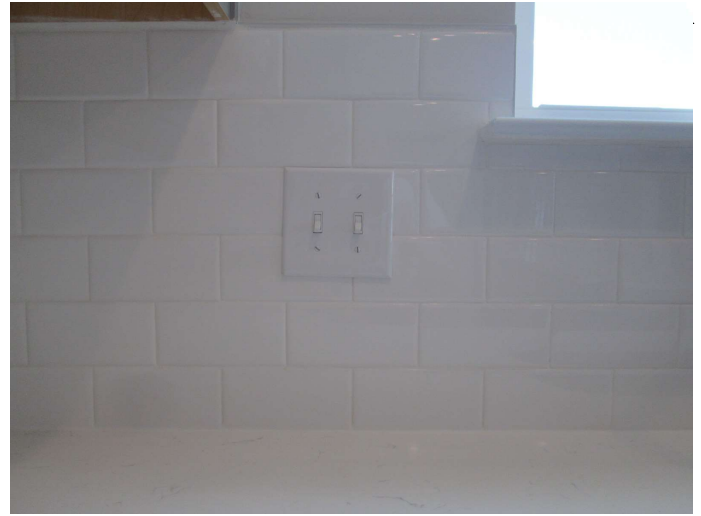
junction box out of level

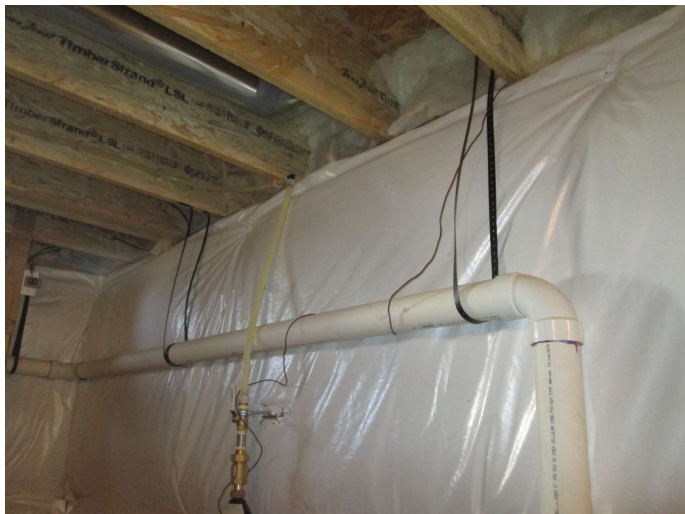
- 1 - unsupported lengths of water supply PEX tubing noted at ceiling level in the basement beneath the basement staircase (have water supply lines properly strapped and supported to prevent damage and leaks)
- 2 - improper use of flexible vinyl straps to support the main and branch sanitary drain lines in the basement (flexible straps do not resist movement and should be replaced with rigid bracing that prevents movement of the pipes) - two flexible vinyl straps on the main sanitary drain line at the right-hand front corner of the basement are loosely wrapped around the drain line and are not providing any support (repairs needed)
- 3 - one screw on the deadfront cover of the tankless water heater could not be backed out (cover not able to be removed)

improper use of flexible vinyl straps - straps loose and not support

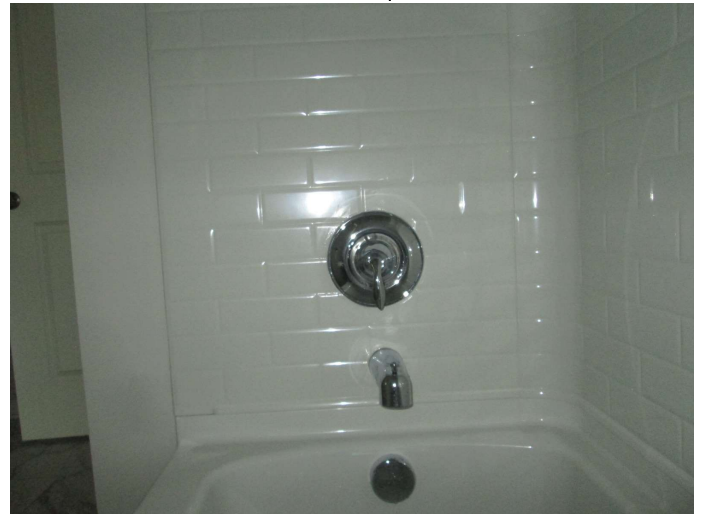
- A LAVATORIES _____
- C TUBS tub spout / tub faucet noted off center above the tub in the 2nd floor hall bathroom
- A SHOWERS _____
- C TOILETS toilet noted installed out of alignment / at a slight angle on the floor in the 2nd floor master bathroom

tub spout and faucet not aligned

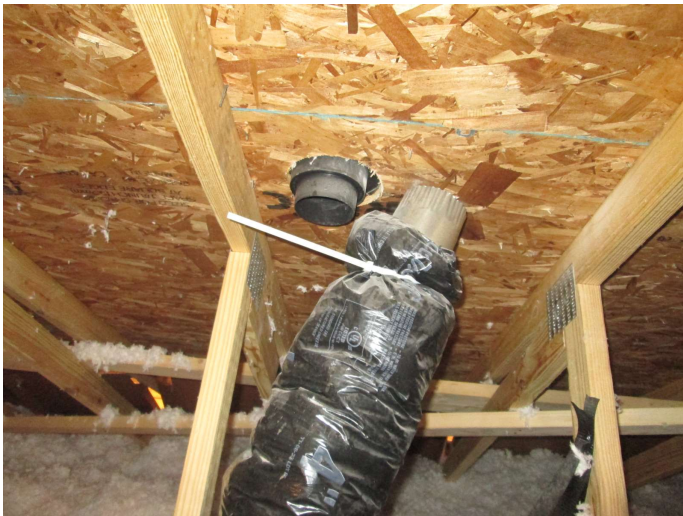
- 1 - clothes dryer exhaust duct is disconnected in the attic area above 2nd floor rooms and will exhaust dryer moisture and lint in the attic (repairs needed to ensure clothes dryer properly vents to the exterior of the house)
- 2 - clothes washer in the 2nd floor laundry room is set in an overflow pan (unable to confirm the presence of a drain line in the pan)
- 3 - refrigerator appears to be installed out of level on the floor in the kitchen (have unit reset to level)
- 4 - door to the clothes dryer in the 2nd floor laundry room hits against the entry door to the room and does not open completely (repair)

dryer exhaust duct disconnected in attic

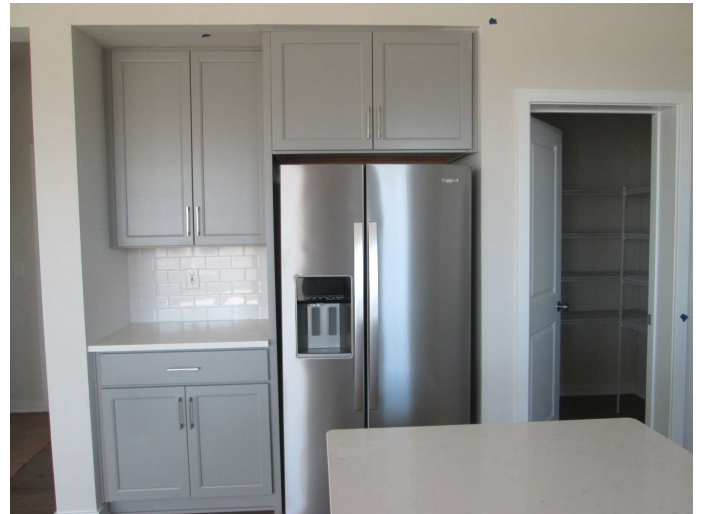
refrigerator not level on floor

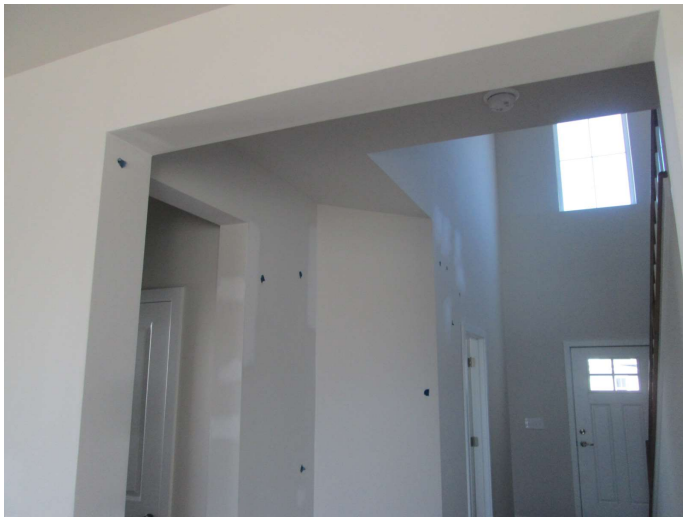
- C** CEILINGS & WALLS multiple incomplete areas of drywall patching and paint noted throughout living areas of the house
- A** FLOORS - WOOD CERAMIC TILE VINYL CARPET LAMINATE OTHER _____
- A** DOORS _____
- A** WINDOWS _____
- A** WATER PENETRATION no visible evidence of moisture penetration on walls or ceilings in living areas of house
- A** STAIRWAYS, HANDRAILS, & BALCONIES _____
- C/1** KITCHEN CABINETS _____
- A** KITCHEN COUNTERTOPS _____

multiple marked imperfections

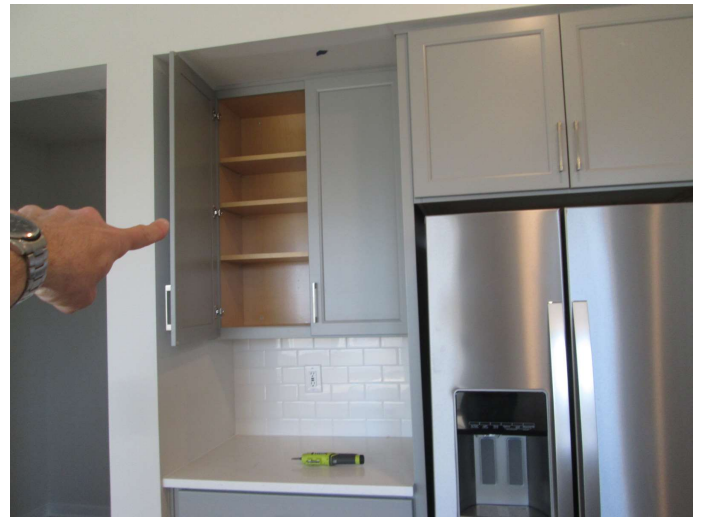
1 - one hinge on kitchen cabinet to the left of the refrigerator in the kitchen makes clicking sound when closed (repair)

cabinet door hinge clicks

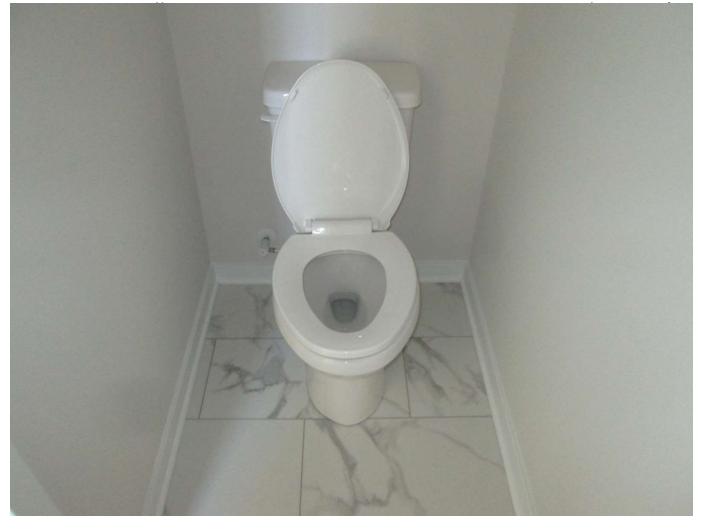
toilet not straight on floor

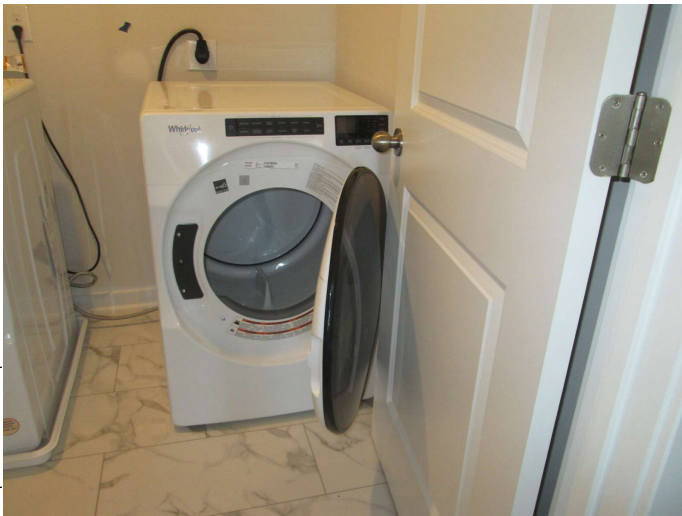
door to clothes dryer hits against entry door to laundry room

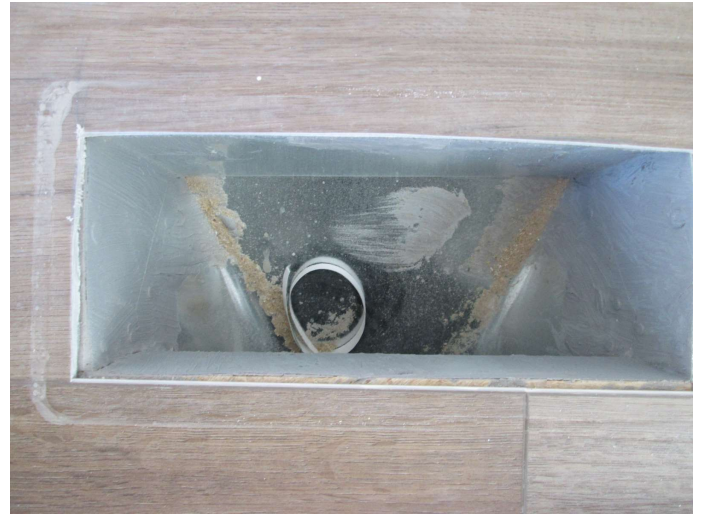
construction debris inside floor levels HVAC ducts

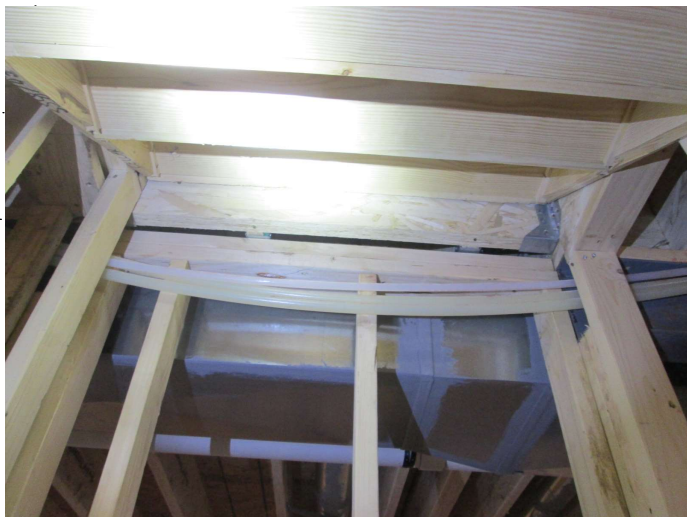
unsupported water supply lines

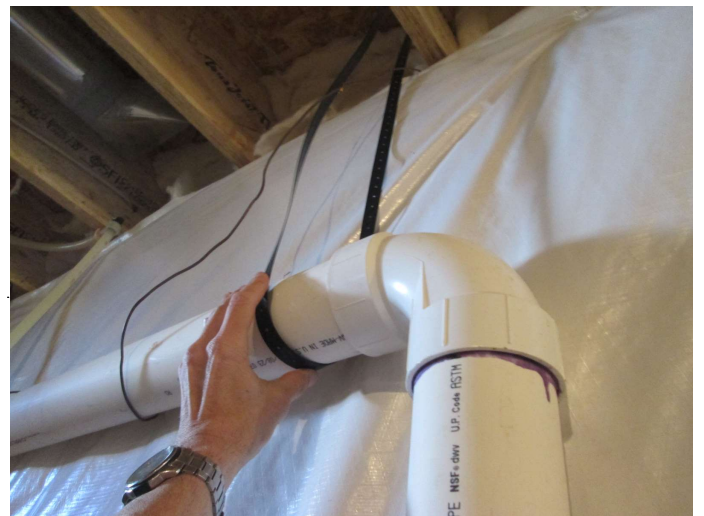
vinyl straps loosely looped around drain line (no support)

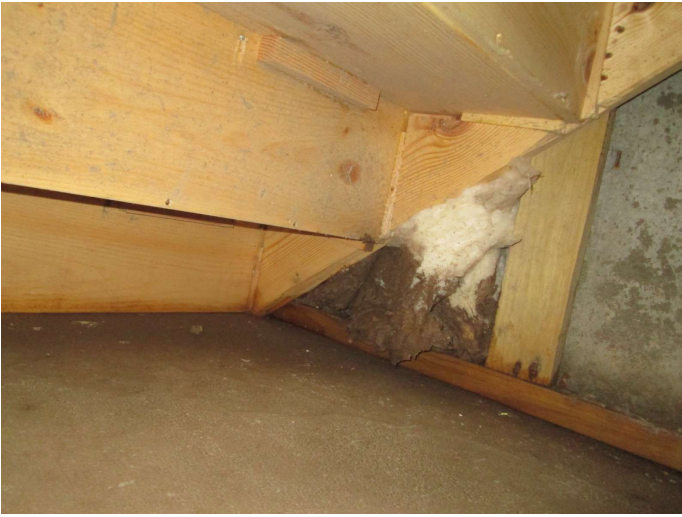
wet insulation beneath basement steps

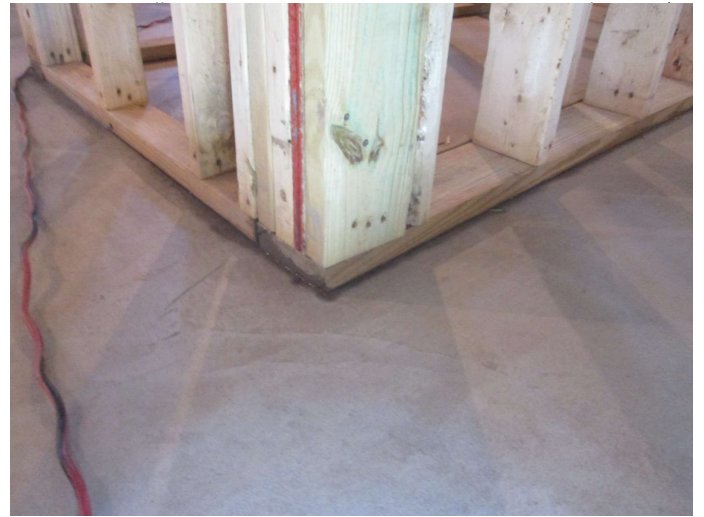
dampness on basement floor

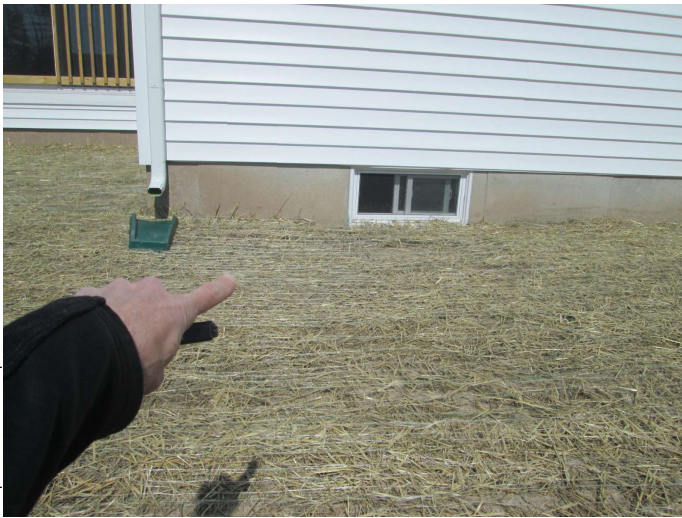
grades sloped towards house

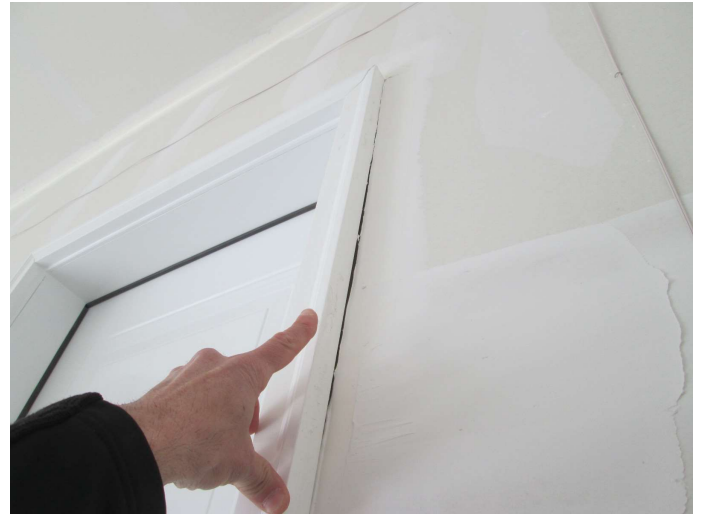
unsealed gaps around door frame inside garage

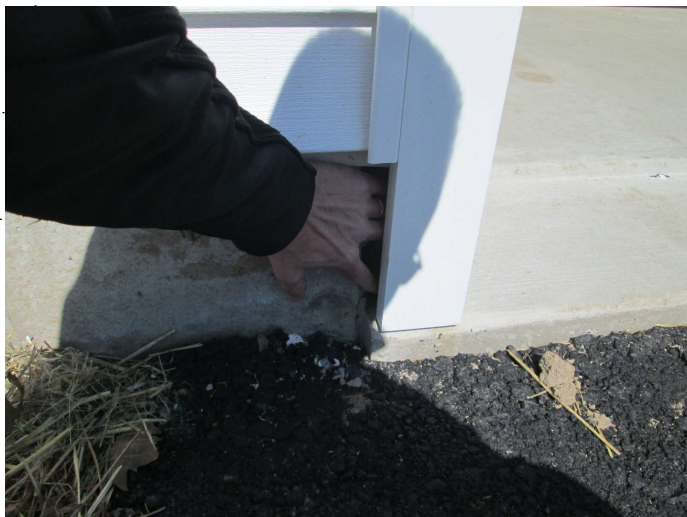
unsealed gaps at garage door frame

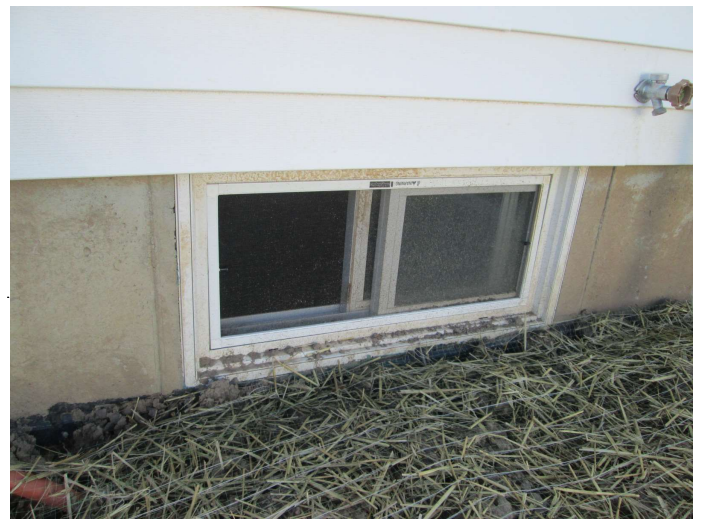
grades sloped towards house
