INSPECTION REPORT

WEATHER CONDITIONS sunny 57°
TIME 9:00am DATE 9/27/2022

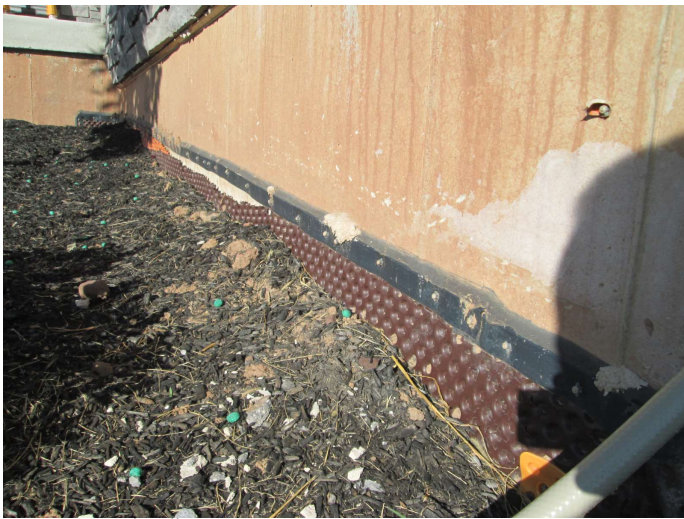
1 - front grades to the left of the front entry door are flat and not properly sloped to divert surface water away from the foundation - front grades to the right of the front entry door are sunken and settlement of ground appears to have exposed the water proofing membrane on the foundation wall (membrane is separated at the top and may allow water penetration behind the membrane - repairs needed) - rear exterior grade at the right-hand rear exterior is flat and not properly sloped to divert surface water away from the foundation - rear exterior grade at the left-hand rear corner of the house has washed out area of grading against the foundation wall (appears to be the result of the sump pump discharge line having exhausted too close to the foundation) - left-hand side grades are sunken (further settlement of grading in this area may result in settlement of the underground gas line and electric service entrance to the house - downspouts need to be extended to exhaust further away from the foundation - sump pump discharge line currently has a temporary extension installed (discharge line should be extended down to grade level and extended to exhaust away from the foundation (exterior surface grades need to be corrected to properly drain surface water away from the foundation)

grades settled - foundation membrane exposed

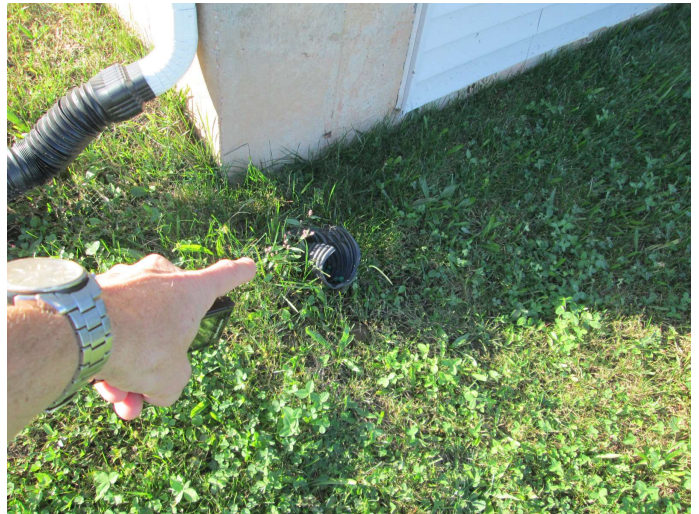
2 - open end of black corrugated drain line noted at ground level exterior right-hand rear corner of the yard (reason for drain line is unknown) - interior of line is filled with damp mud - if drain line is intended to exhaust ground or roof water, mud will prevent water from exhausting out of the line

drain clogged

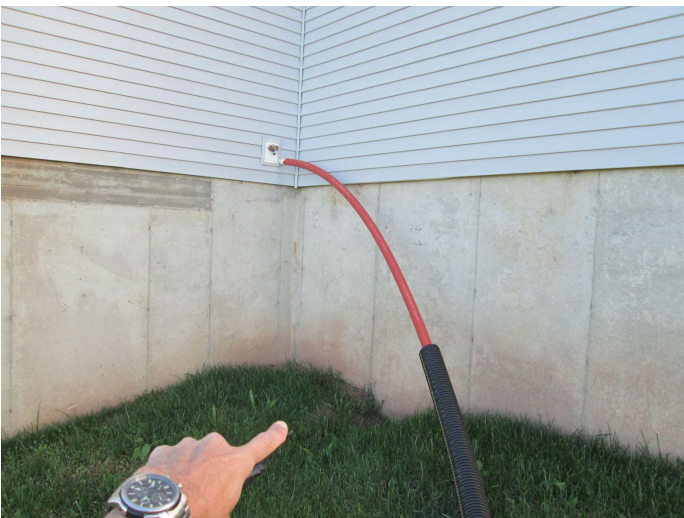
washout of grade beneath sump pump pipe

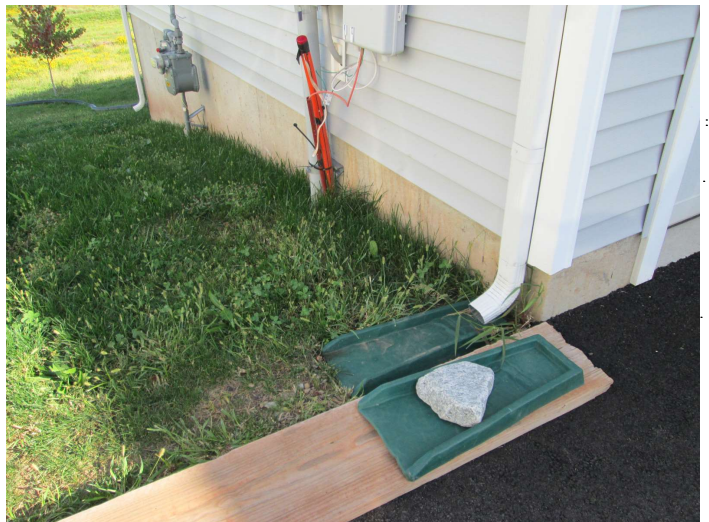
downspouts exhausting too close to foundation

C/2 **GUTTERS & DOWNSPOUTS** **downspouts should be extended to exhaust roof water further away from the foundation**

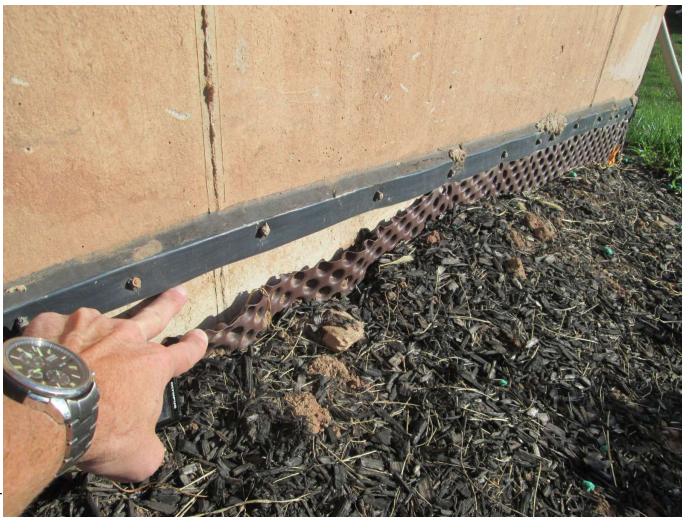
- 1 - front grades to the right of the front entry door are sunken and settlement of ground appears to have exposed the water proofing membrane on the foundation wall (membrane is a separated at the top and may allow water penetration behind the membrane - repairs needed)

foundation membrane separated

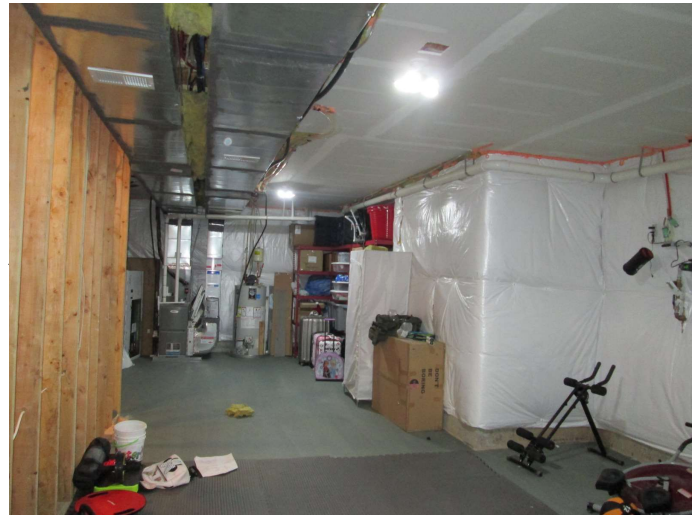
- 2 - interior foundation walls, floor, and ceiling in the basement not totally observable due to finished areas (95% finished), stored property on floors and against walls, and insulation installed against the foundation walls - no visible evidence of water penetration noted in the basement // sump pit with pump noted inside a left-hand closet in the basement - standing water in the pit (pump in pit tested and noted as operable) - due to finished areas in the basement, recommend having a backup sump pump system installed

basement not totally observable

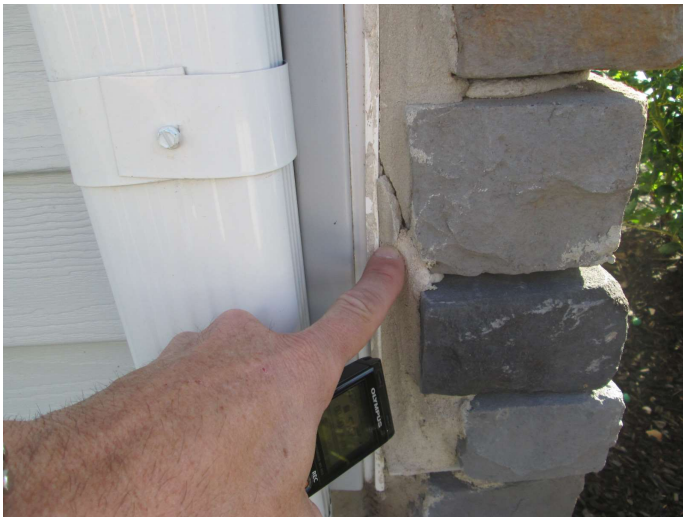
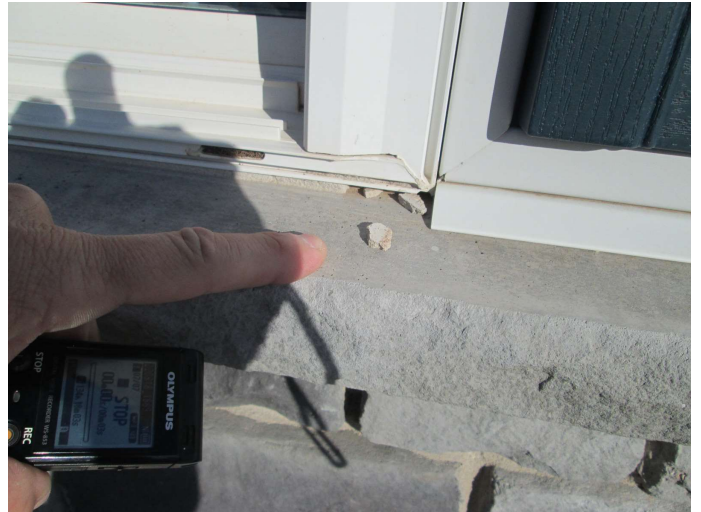
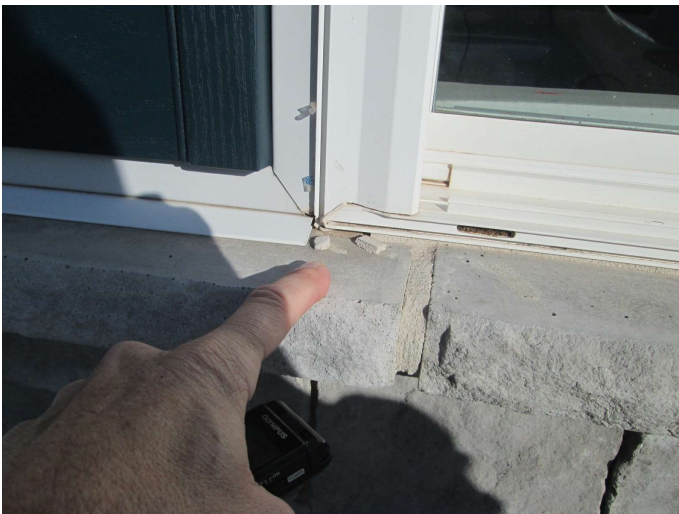
damaged pointing

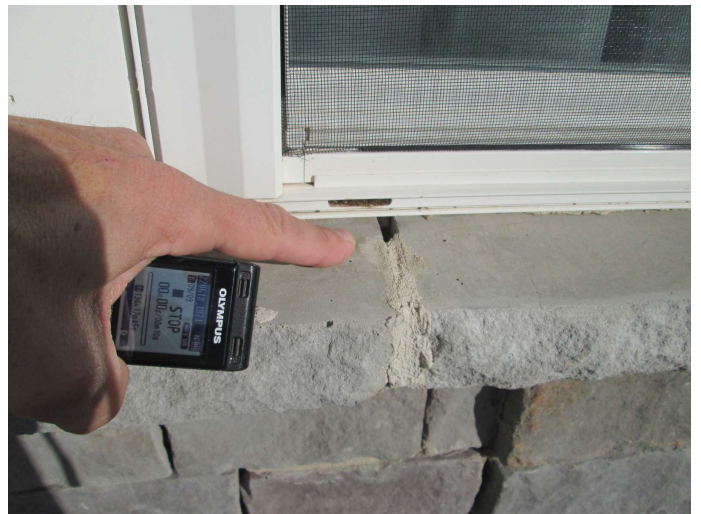
1 - voids in pointing noted between stones on the front stone ledge beneath 1st floor front windows to the left of the front entry door (repairs needed) // recommend having junction between concrete foundation wall and vinyl siding on the rear exterior wall sealed to help prevent moisture and insect entry

voids in pointing

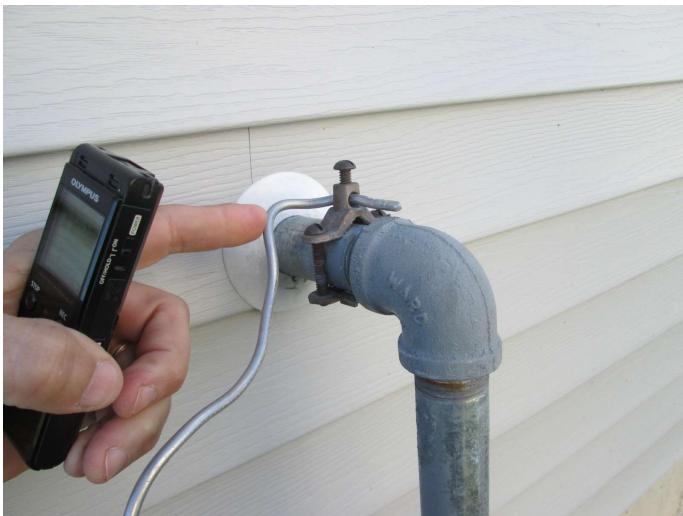
- 1 - see comment #1 in GRADING & DRAINAGE NOTES on page #2
- 2 - exterior bonding conductor on the gas meter pipe is loose and not properly secured (repair)

bonding conductor not secured

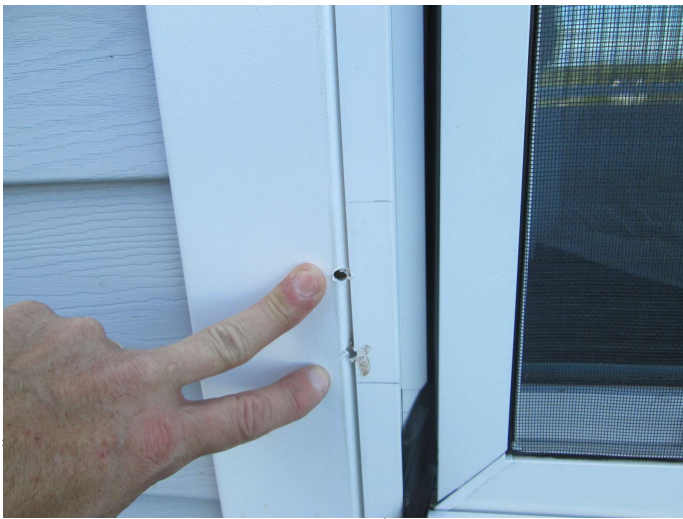
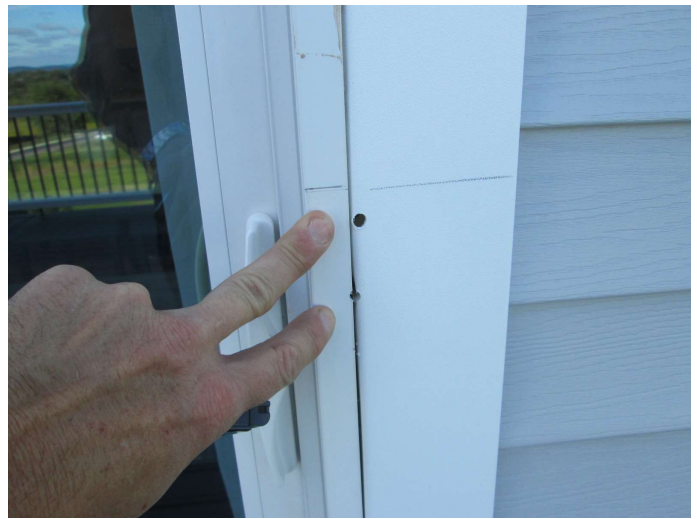
1 - multiple unsealed holes in vinyl trim around the 1st floor rear exterior slider (have holes sealed)

holes in trim capping

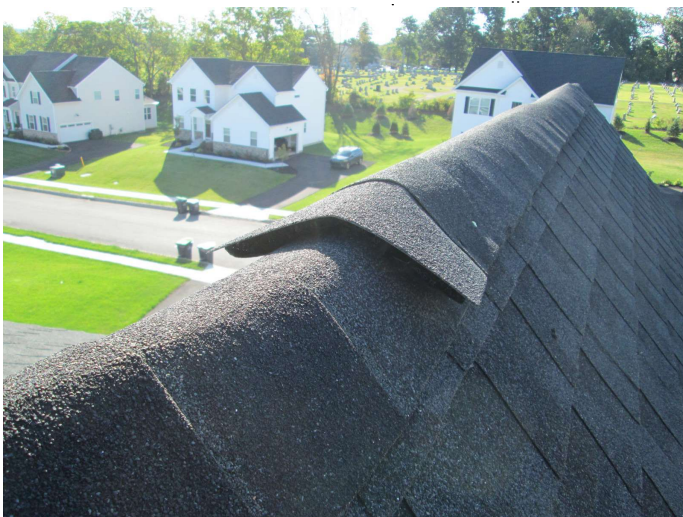
1 - roof above the front entry door is covered with one layer of dimensional asphalt shingles - partially ripped tab on shingle above the front roof gutter and loose nails noted on the roof surface // left-hand side gabled roof above the single car garage is covered with one layer of dimensional asphalt shingles - loose nails noted on the roof surface and exposed unsealed nail heads on face-nailed shingles on the ridgeline shingles // main gabled roof is covered with one layer of dimensional asphalt shingles - loose nails noted on the roof surfaces and exposed unsealed nail heads on face-nailed shingles on the ridgeline shingles (all exposed nail heads on roof should be sealed with tar or caulk sealant to prevent leaks and all loose nails and construction debris on the roof should be removed) // end of one ridge vent on the front of the main roof is not properly secured down and is lifting off the roof surface (repair)

ridge vent end and shingles not properly secured

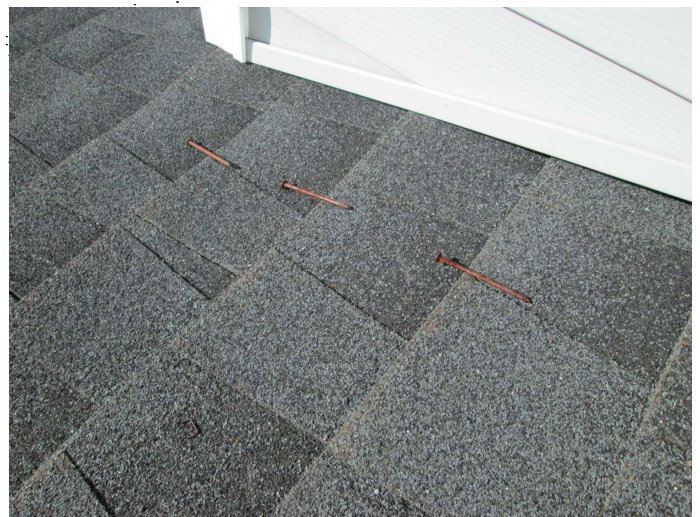
loose nails and debris on roof

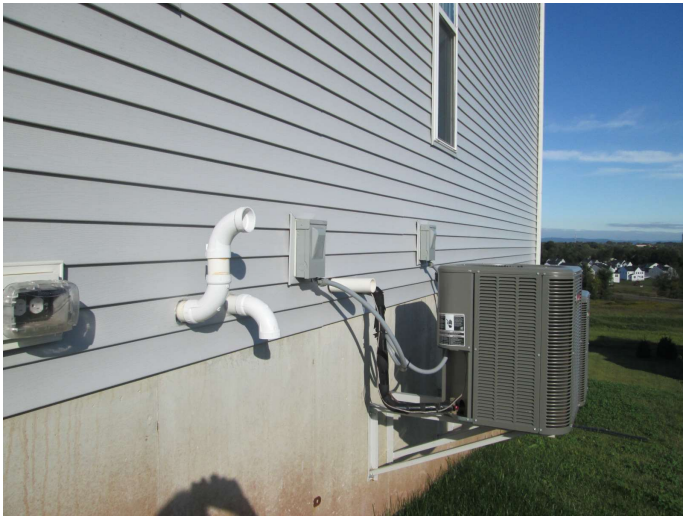
1 - gas-fired high efficient furnace and gas fired high efficient water heater in the basement vent to the exterior via PVC pipes through the right-hand side wall
- high efficient gas-fired furnace in the 2nd floor utility closet vents to the exterior via PVC pipes through the roof // direct vent hood noted on the rear exterior wall for the gas fireplace in the 1st floor rear family room

furnace and water heater vent pipes

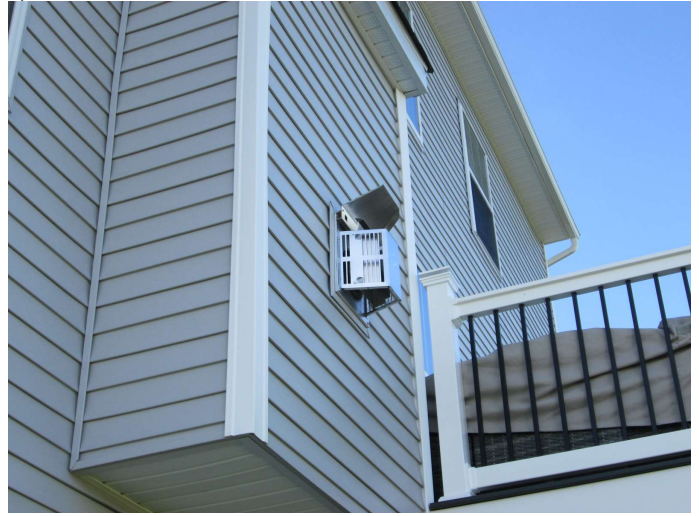
fireplace vent hood

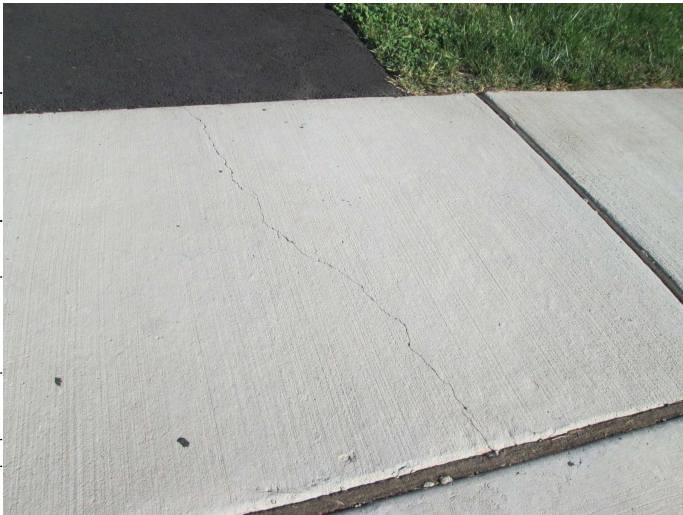
crack on sidewalk slab

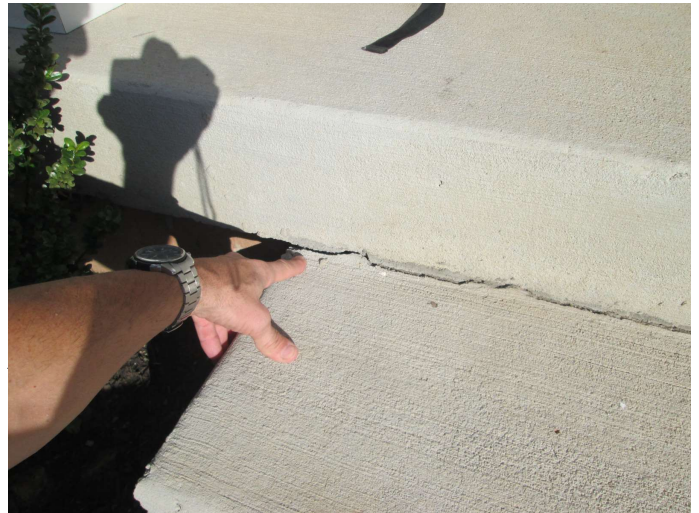
crack at front entry step

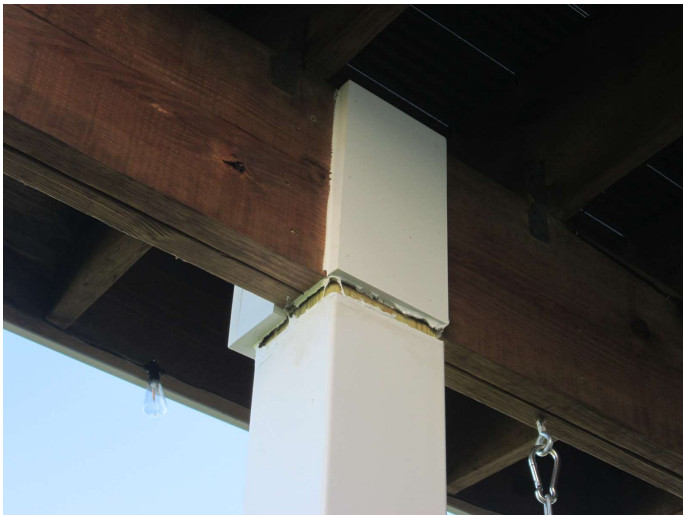
1 - PVC sleeves installed on the deck support posts appear to have settled at the top of the posts (caulk seals are separated - replace failed caulk seals)

separated caulk seal at top of vinyl sleeve on deck post

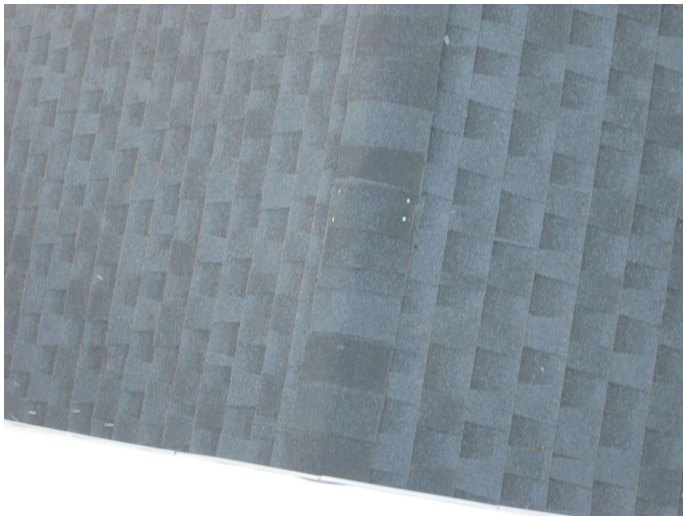
- 1 - two car garage and separate single car attached garages noted - garage interiors not totally observable due to stored property and car parked in the two car garage
- 2 - left-hand side gabled roof above the single car garage is covered with one layer of dimensional asphalt shingles - loose nails noted on the roof surface and exposed unsealed nail heads on face-nailed shingles on the ridgeline shingles
- 3 - damaged mortar noted on the stone ledge beneath one of the front garage windows - cracked pointing at left-hand front corner of exterior garage wall next to garage door (repairs needed)

loose nails and exposed nail heads on garage roof

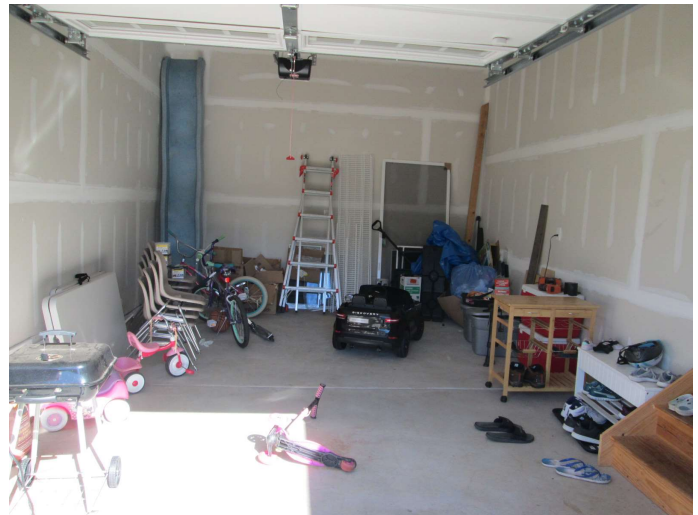
property inside garage

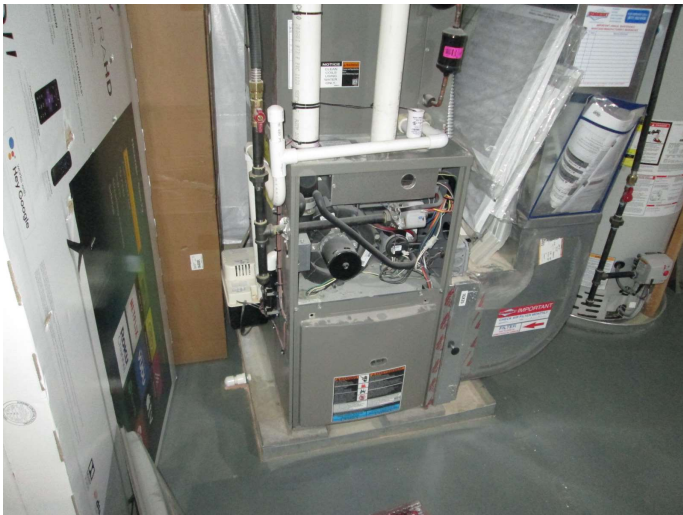
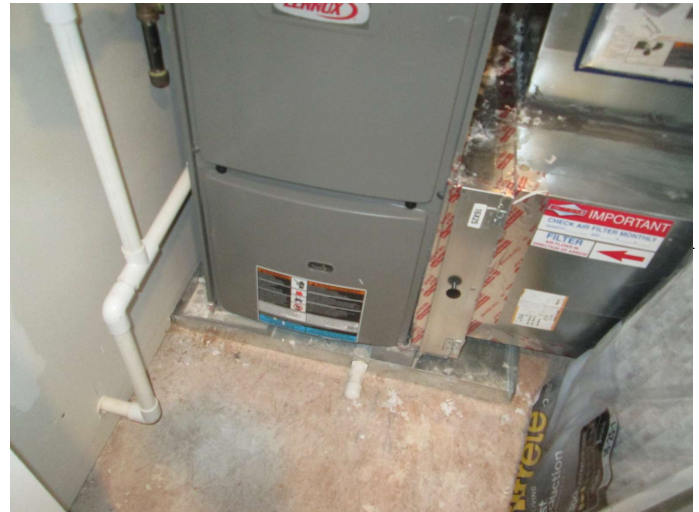
- 1 - zone #1 heat source in the basement is a 1 year old gas-fired high efficient forced air furnace in the front utility area of the basement (system tested and noted as operable) - unit is set in an overflow pan but pan has no water sensing shut off module and drain port on the pan is plugged (no drain line installed on the pan - condensate water may overflow the pan in the event of a malfunction of the furnace or AC condensate drain system - recommend having a water sensing shut-off module installed in the pan // zone #2 heat source located in a 2nd floor utility closet off the laundry room is a 1 year old gas-fired high efficient forced air furnace (system tested and noted as operable) - unit is set in an overflow pan but pan has no water sensing shut off module and drain port on the pan is plugged (no drain line installed on the pan - condensate water may overflow the pan in the event of a malfunction of the furnace or AC condensate drain system and result in water damage to finished areas around the closet or below on the 1st floor ceiling) - furnace should have a water sensing shut-off module installed in the pan (all insulation debris in the overflow pan of the zone #2 furnace should be removed)

overflow pans beneath furnaces have no drain lines & no water sensing shut offs

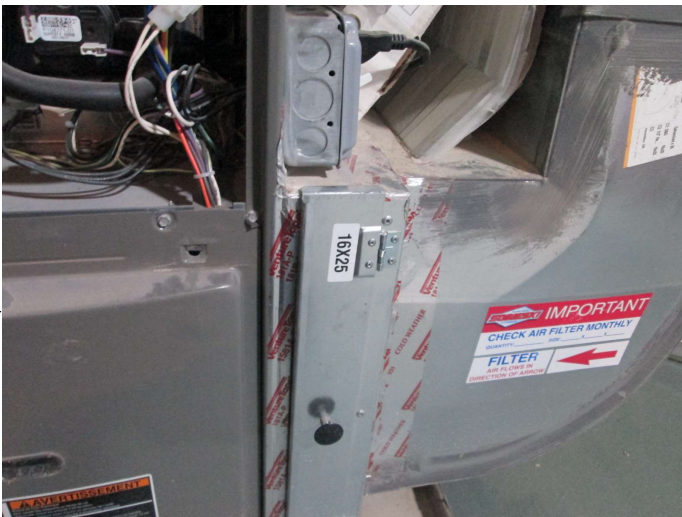
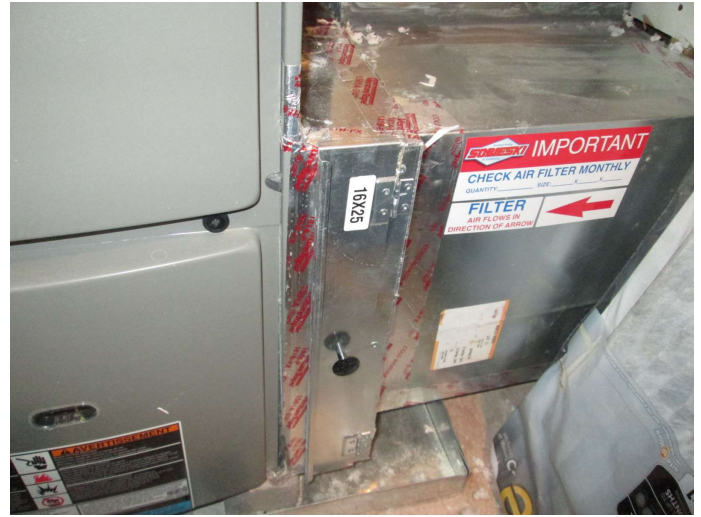
- 3 - zone #1 air filter is a 16x25x1 filter located in the filter bay next to the furnace in the basement // zone #2 air filter is a 16x25x1 filter located in the filter bay next to the furnace in the 2nd floor utility closet (both air filters are dirty and should be replaced)

location of zone #1 air filter

location of zone #2 air filter

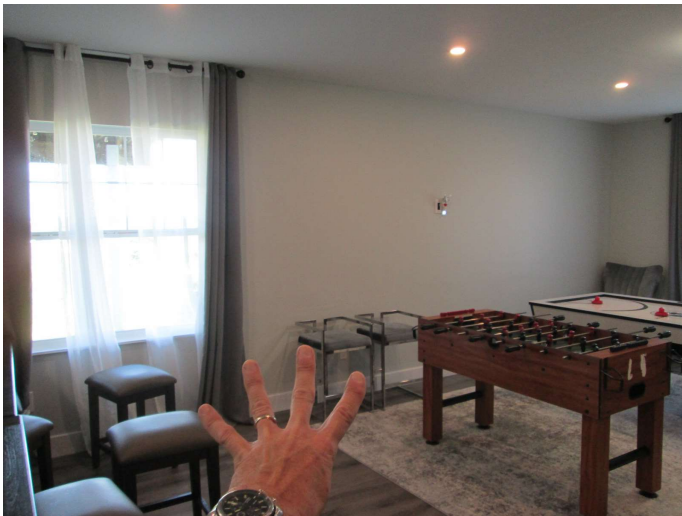
four outlets in basement with reverse polarity

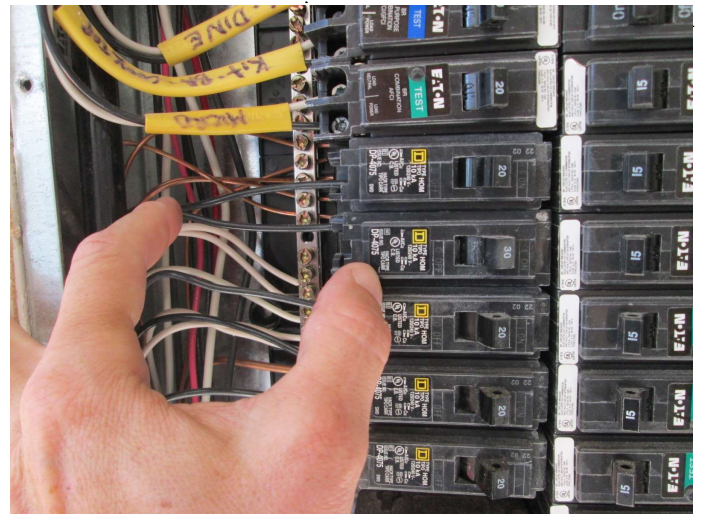
- 1 - one 30 amp circuit breaker inside the service panel is improperly wired with an undersized 12 gauge wire (fire hazard - repairs needed) // some circuit breaker positions inside the service panel are not fully labeled
- 2 - four outlets along the rear wall in the finished area of the basement have reverse polarity wiring configuration (shock hazards - repairs needed) // multiple outlets and light switches noted missing coverplates in the utility areas of the basement (have coverplates installed)
- 3 - outlet above countertop in the basement next to the wet bar sink is not a GFI protected outlet (should be upgraded to a GFI outlet for safety due to close proximity to water source)

30 amp breaker with undersized 12 gauge wire

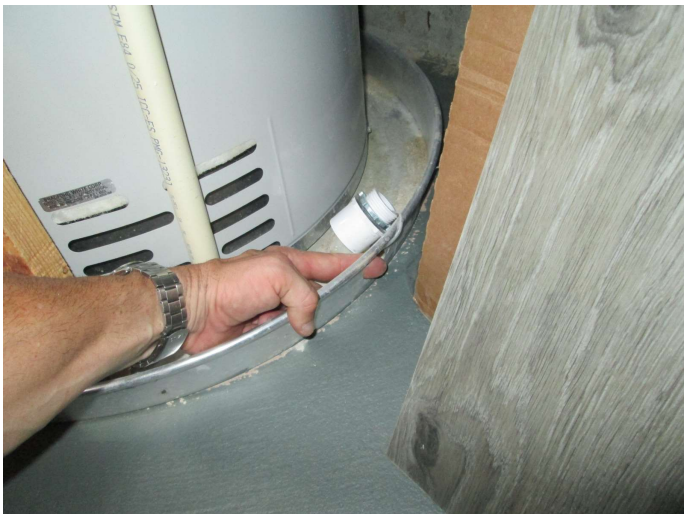
- 2 - high efficient gas water hater tank in the basement is set in an overflow pan but pan has no drain line attached and drain port on the pan is open (may result in water damage to stored property and finished areas in the even of a leak on the tank - recommend having drain port on the pan plugged and water sensing shut-off valve installed on the cold water supply line to the tank)

no drain line on water heater overflow pan

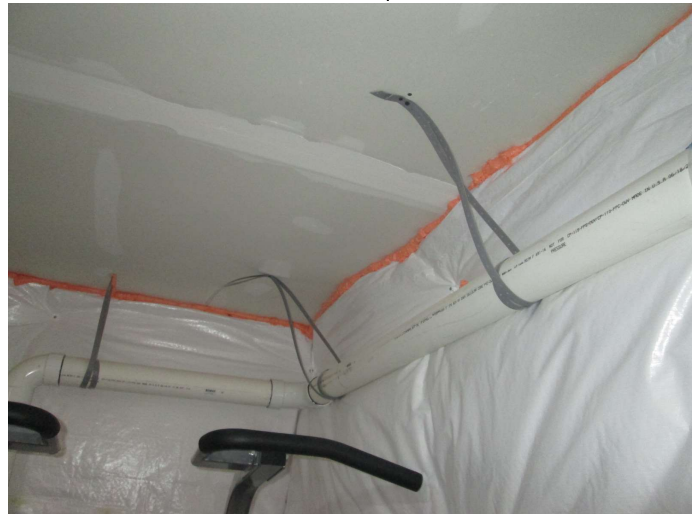
- 1 - improper use of flexible vinyl straps to support the main and branch sanitary drain lines in the basement (flexible straps do no resist upward movement of the pipes and may result in damage to pipes) - three flexible straps used to support the main drain line at the front of the basement are loosely looped around the drain line and are no providing any support (have flexible straps replaced with rigid hangers)

improper / inadequate strapping support on drain lines

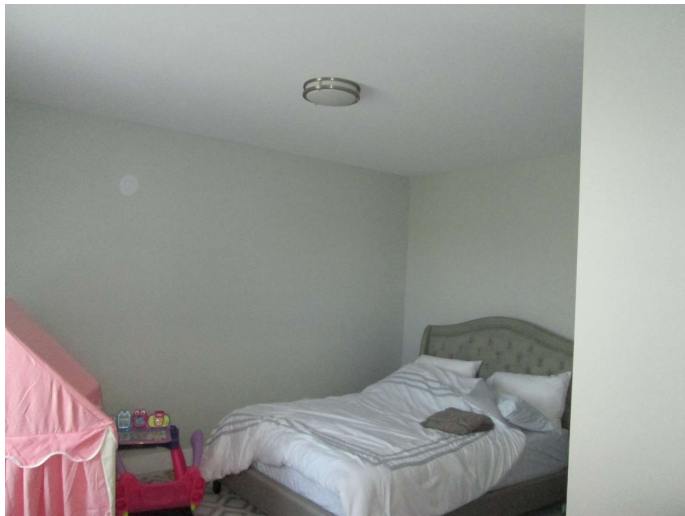
1 - no smoke detector noted in the rear basement level bedroom (have installed for safety) // dust covers on smoke detectors in the basement should be removed

no smoke detector in basement bedroom

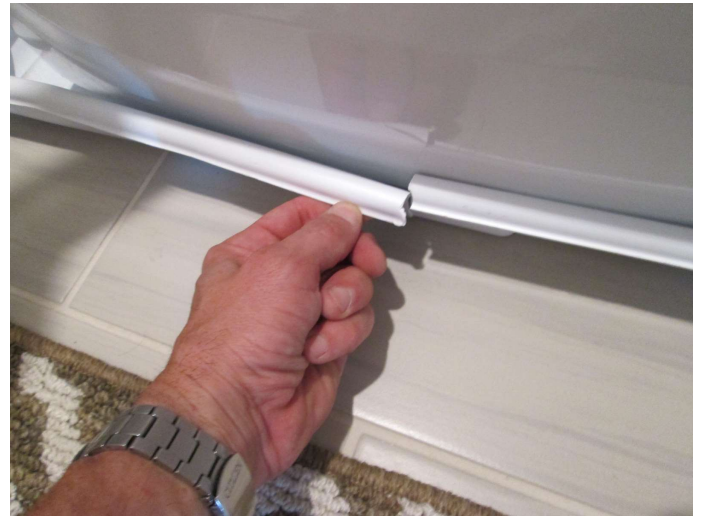
2 - washing machine in the 2nd floor laundry room is set in an overflow pan (unable to confirm the presence of a drain line on the pan) - front of the overflow pan is cracked and should be replaced

washing machine overflow pan cracked

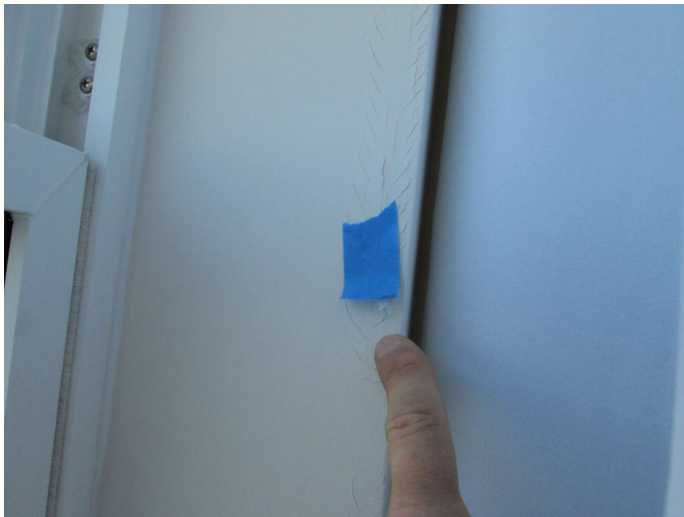
- 1 - evidence of water penetration noted on rear wall in the 1st floor family room to the left of the fireplace (blistered paint skin on the wall - leak source needs to be corrected)
- 2 - ceiling in the 2nd floor utility closet that houses the zone #2 furnace is not properly sealed and is open to the attic area above 2nd floor rooms (needs to be properly sealed, draft stopped, and all penetration sealed for safety, to prevent heat loss, and to prevent attic insulation from falling down into the closet - repairs are needed)
- 3 - window in the 2nd floor right-hand shared bathroom is difficult to open and close (repair)

water penetration next to family room window

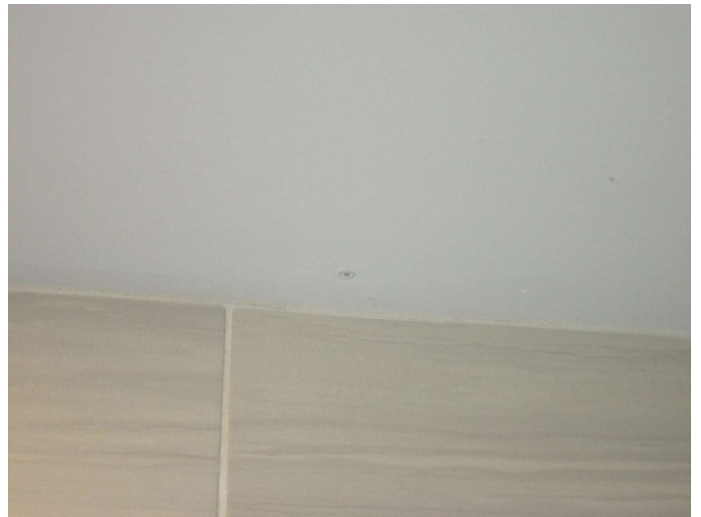
C/1/2 CEILINGS & WALLS multiple exposed screw heads noted on the ceiling above the 2nd floor master bathroom shower stall

exposed screw heads on ceiling above shower stall

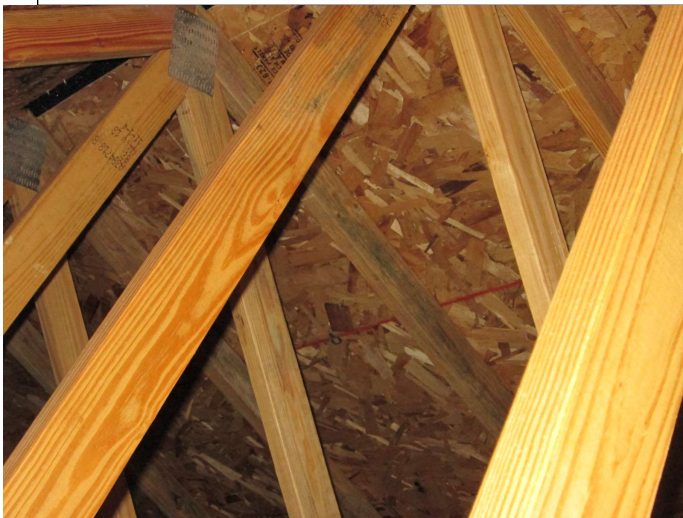
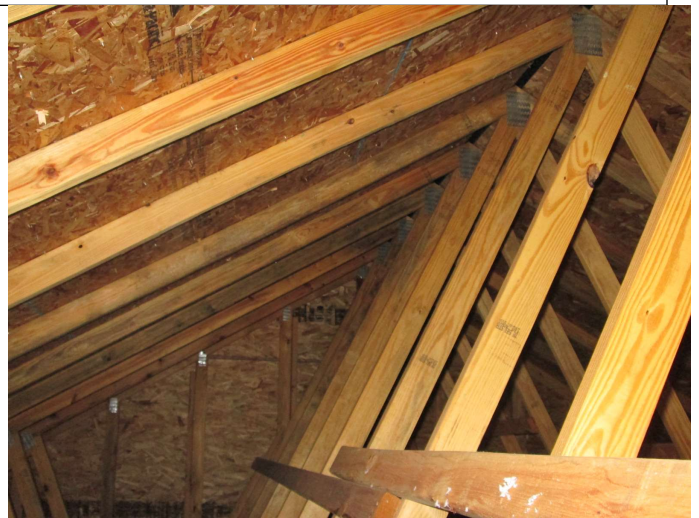
- 1 - attic area above the 2nd floor rooms was accessed via panel on the ceiling of the 2nd floor laundry room - due to HVAC ducts and insulation levels in the attic, attic interior was not totally accessible or observable
- 2 - multiple roof trusses in the right-hand side area of the attic have mold / fungal growth on the truss members (all growth needs to be removed)

mold and trusses in attic

mold on trusses in attic

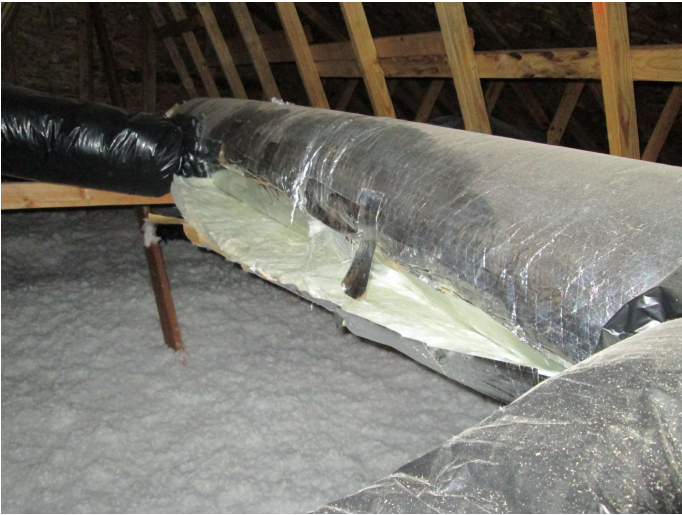
- 2 - section of insulation on HVAC supply duct in the attic area above 2nd floor rooms has come loose exposing the metal duct (insulation needs to be properly resecured to the duct)

unsecured insulation on duct in attic

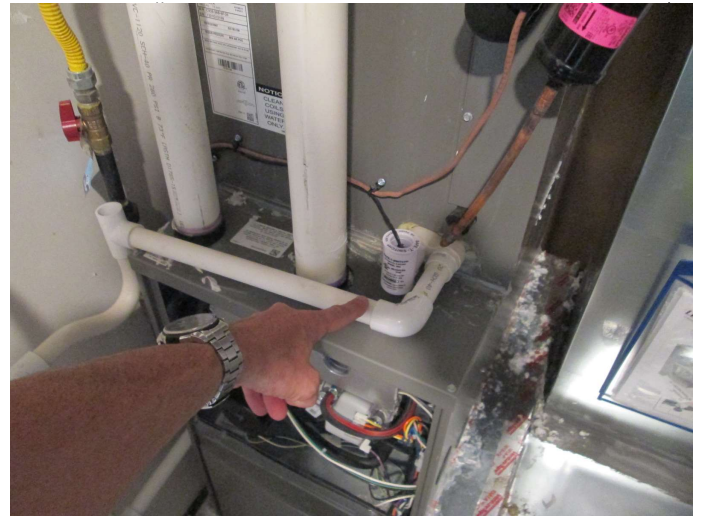
air leaks on zone #2 furnace cabinet

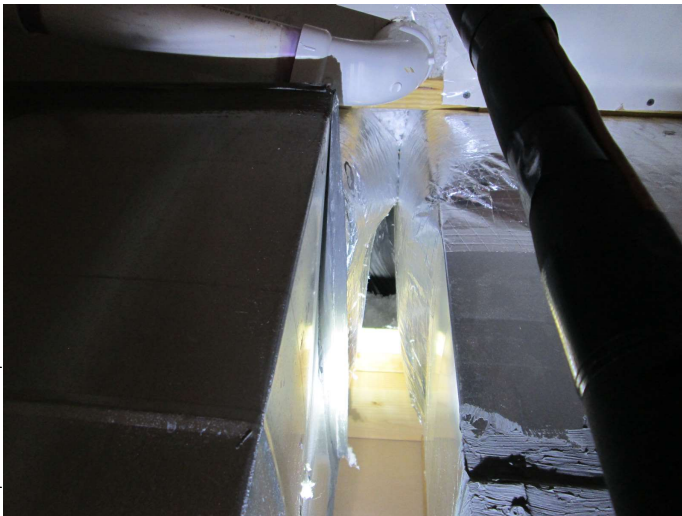
ceiling above zone #2 furnace open to attic space

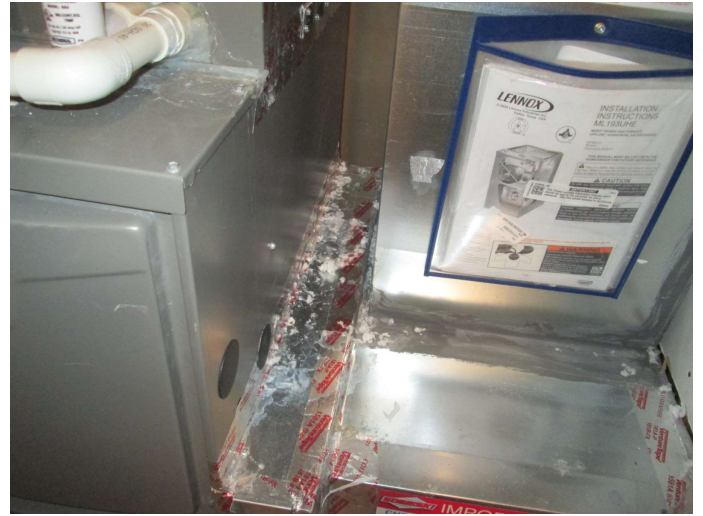
insulation from attic around zone #2 furnace (ceiling open to attic)

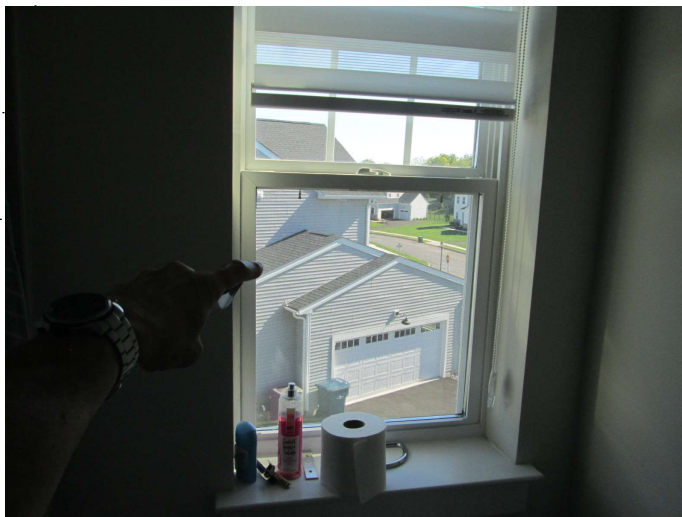
bathroom window difficult to open and close

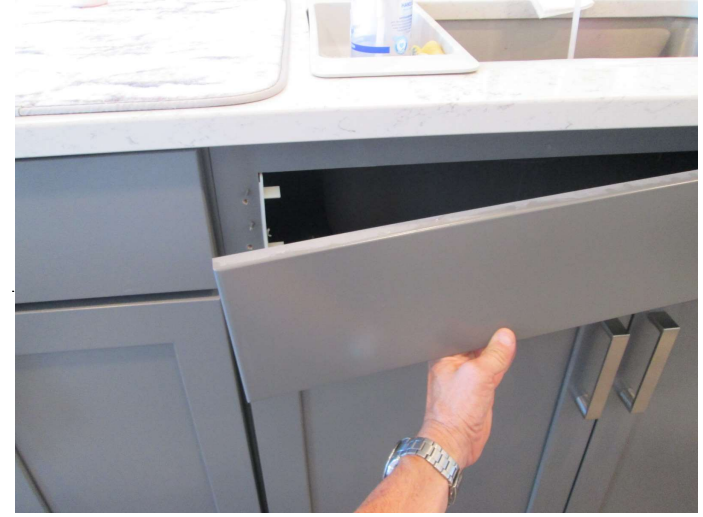
C KITCHEN CABINETS false drawer front in kitchen beneath the sink is not properly secured (repair)

loose drawer front in kitchen

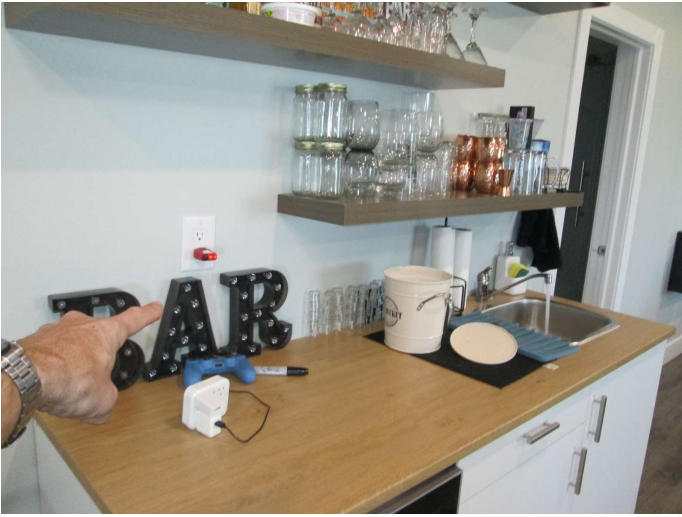
outlet above wet bar not GFI

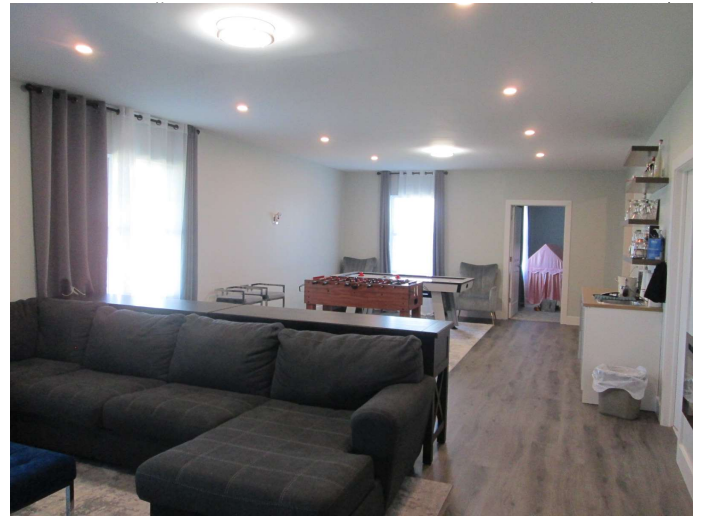
C/1 HEAT SOURCE _____
 A BURNER / ELEMENT _____
 C/2 DUCT WORK PIPES & CIRCULATOR no heat source or AC noted in the finished area of the basement or the basement bedroom
 C/3 AIR FILTER _____
 A HEATING THERMOSTAT zone #1 thermostat located in 1st floor hallway - zone #2 thermostat located in 2nd floor master bedroom

no heat or AC in finished rooms of basement

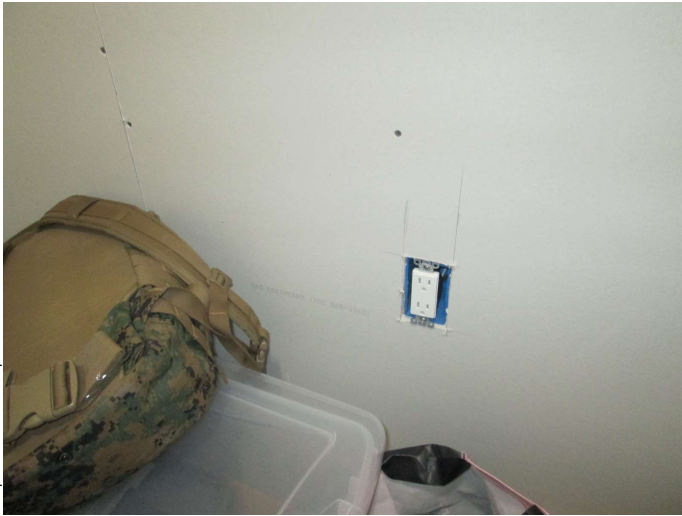
multiple coverplates missing

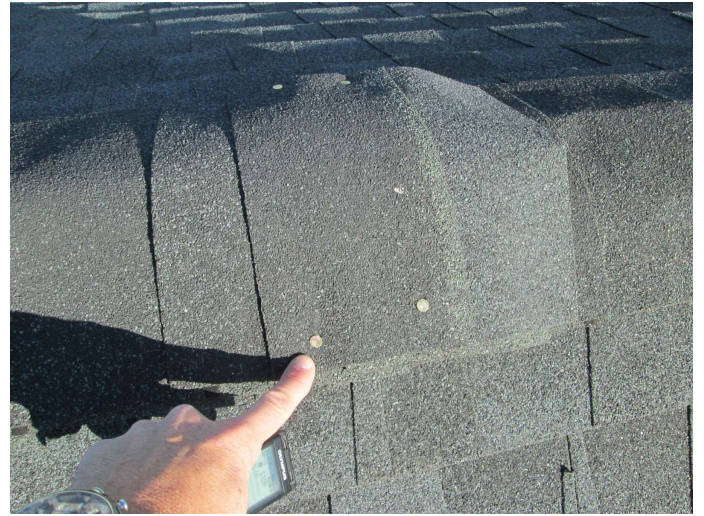
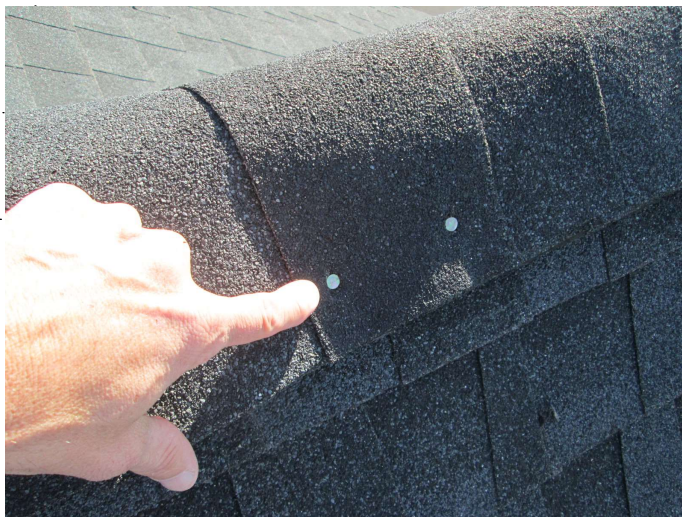
exposed unsealed nail heads on roof surfaces

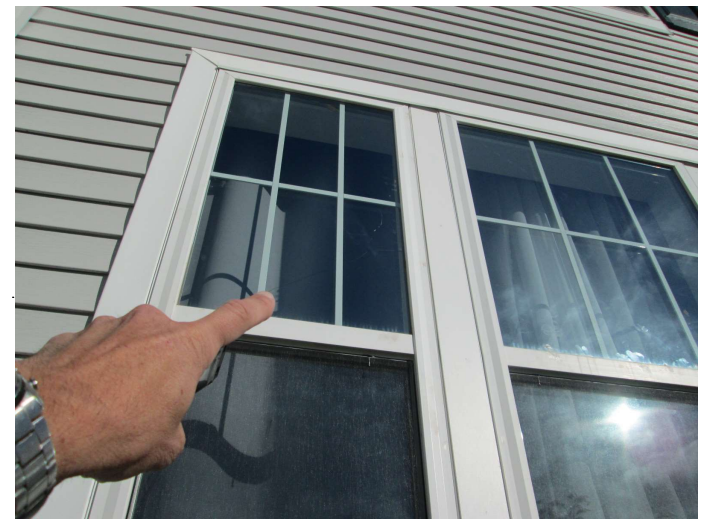
C/3 WINDOWS broken interior pane on one window at the front of the 1st floor office room (replace broken window)

broken pane on front office window
