INSPECTION REPORT

WEATHER CONDITIONS sunny 62°
TIME 12:45pm DATE 3/12/2024

- SINGLE HOME
SEMI-DETACHED
ROWHOME
SINGLE STORY
MULTI-STORY
OTHER
OCCUPIED VACANT new construction

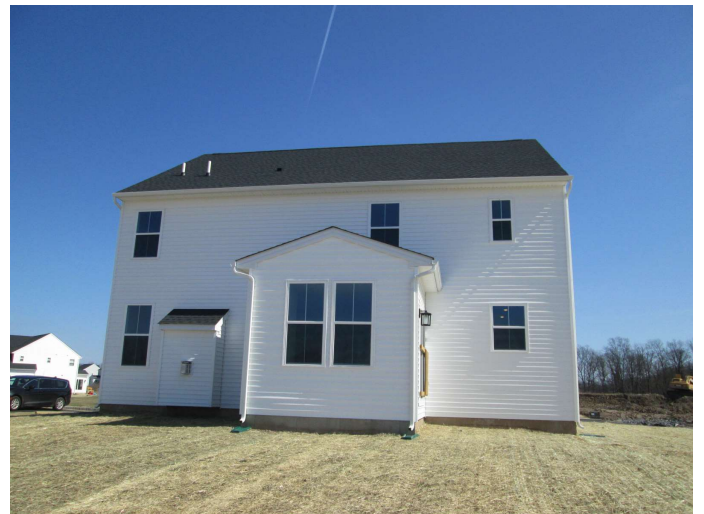
view of rear

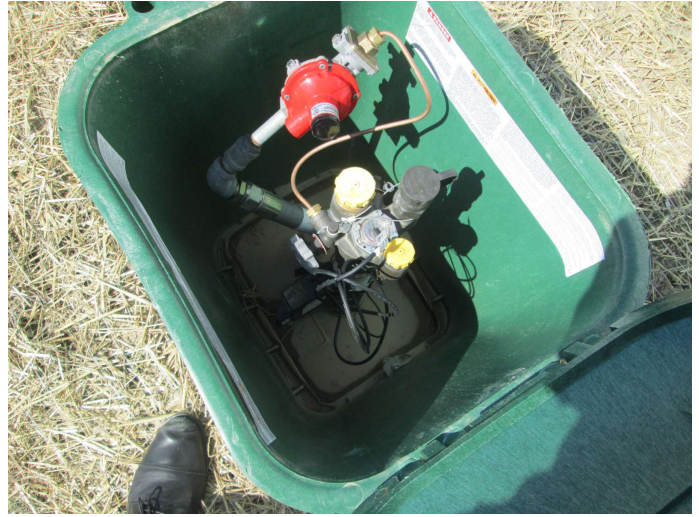
1 - buried propane gas tank noted in the left-hand side yard - main gas service line to the house noted along the left-hand side exterior

view of tank gauge

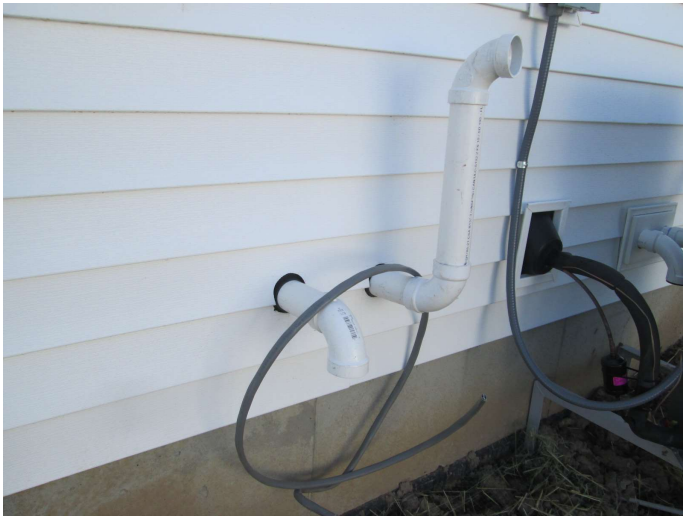
1 - high efficient gas-fired furnace and high efficient gas-fired water heater in the basement vent to the exterior via PVC pipes through the right-hand side exterior wall

furnace vent pipes

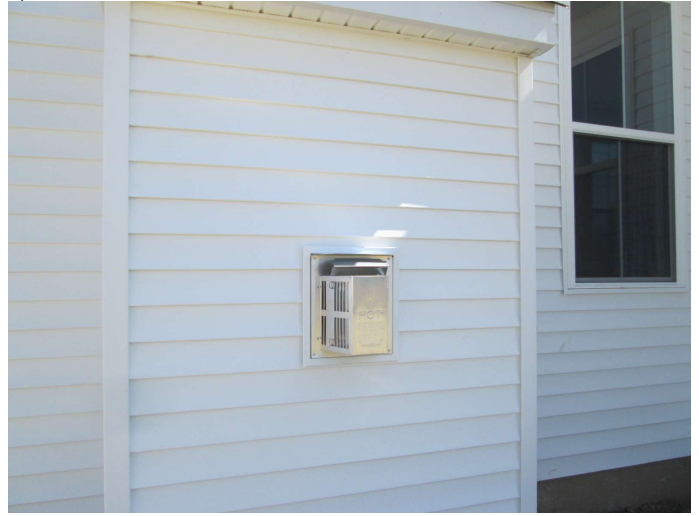
2 - direct vent hood noted on the rear exterior wall vents combustion gases from the gas fireplace in the 1st floor rear family room

fireplace vent hood

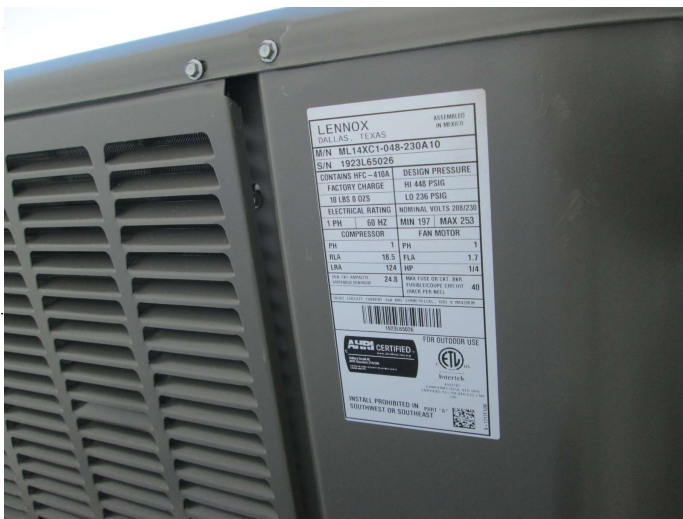
1 year old 4 ton AC condenser

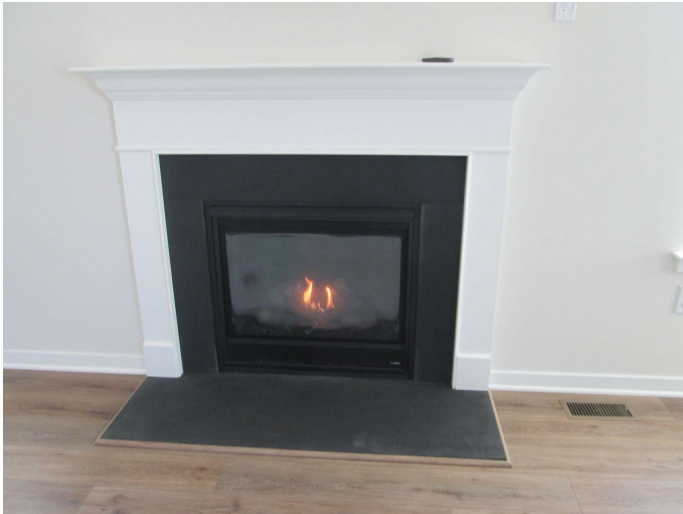
view of fireplace

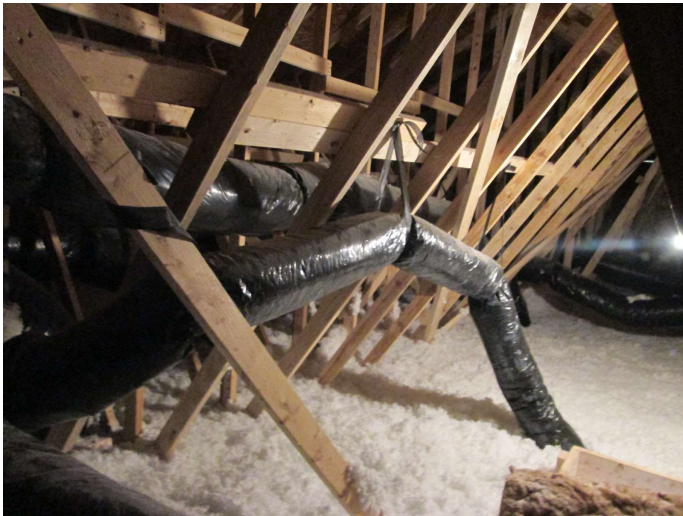
1 - attic area above the 2nd floor rooms was accessed via panel on ceiling in the 2nd floor laundry room (attic interior not totally observable due to insulation levels and HVAC ducts in the attic)

limited view of attic

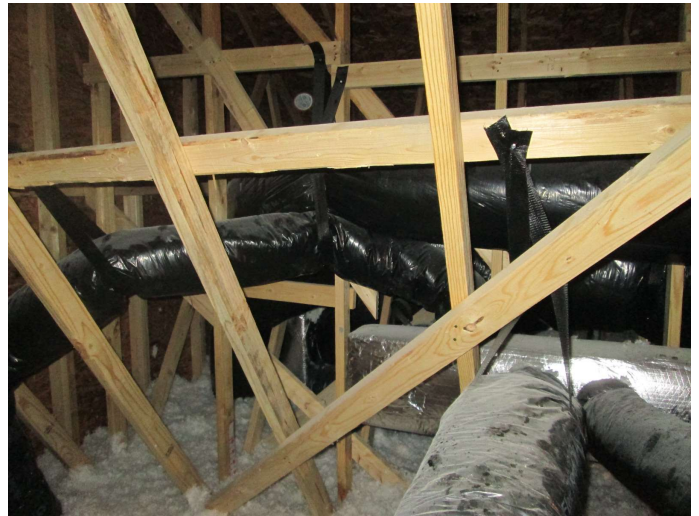
limited view of attic

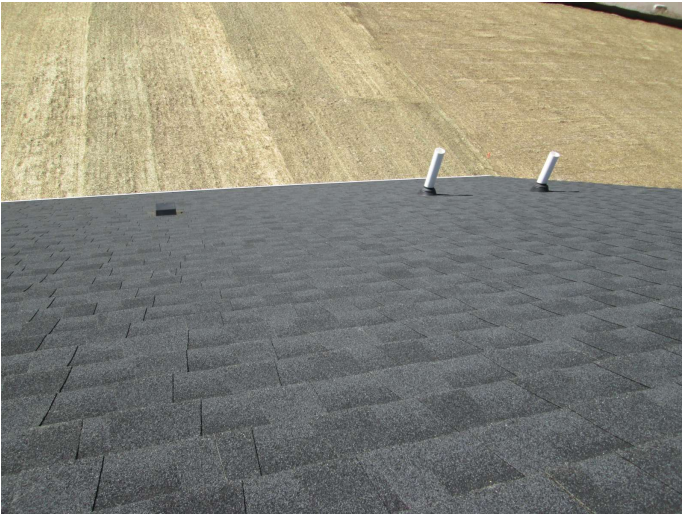
view of roof
